AN ANALYSIS OF VEHICLE FIRES AND  
POTENTIAL METHODS TO REDUCE THEIR  
SEVERITY THROUGH MORE STRINGENT  
MATERIAL STANDARDS

Evan A. Patronik, Master of Science in  
Fire Protection Engineering, 2008

Thesis submitted to the Faculty of the Graduate School of the  
University of Maryland, College Park, in partial fulfillment  
of the requirements for the degree of  
Master of Science  
2008

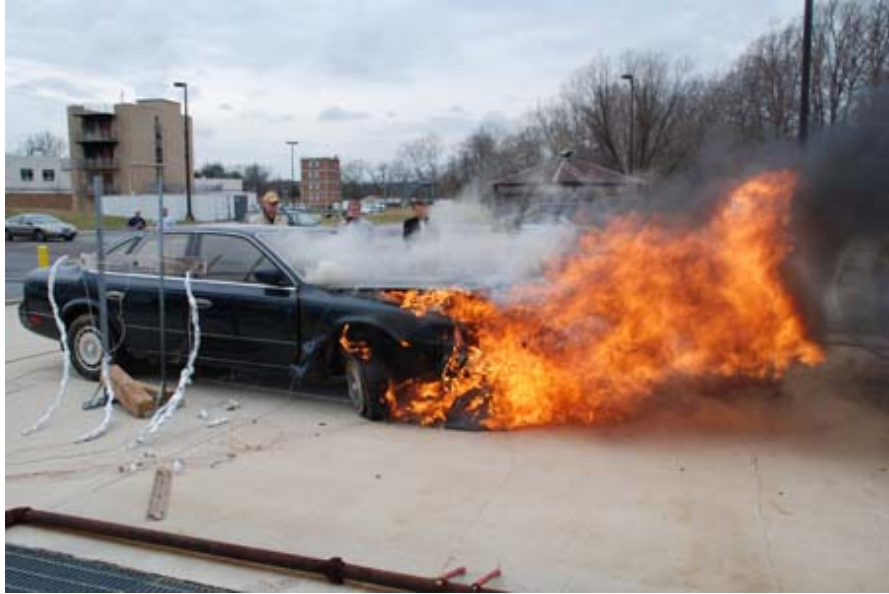
In the second test, the Infiniti J30 front end was facing away from the wind. Rather than drawing the flames back toward the vehicle, flames were pushed ahead of the vehicle; this allowed the engine compartment fire to propagate more normally through the engine compartment. Wind speeds for this test were high as well, as shown in Figure 4.26.

**Figure 4.26. Wind effects on FR Material**

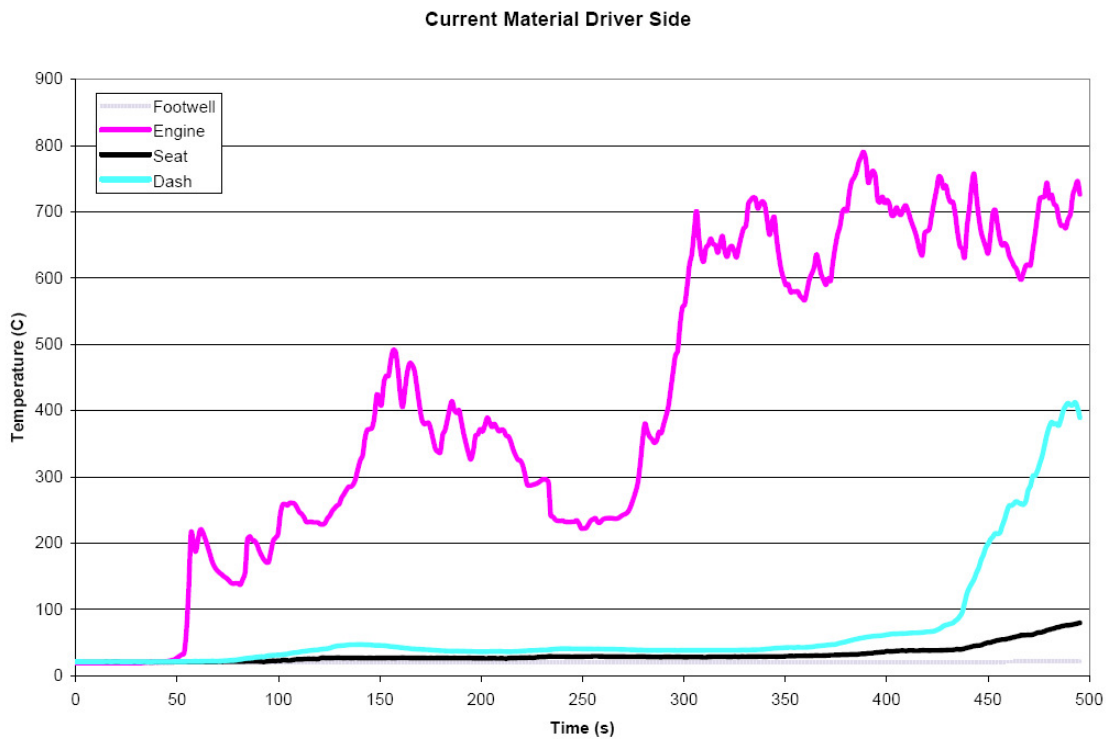
**Figure 4.27. Current Material Driver Side Temperature Results**

Figure 4.27 shows the driver side temperatures measured in the Current Material vehicle fire. Engine compartment temperatures are highest, followed by the dashboard; these results correlate with findings from previous research reviewed in Chapter 2.

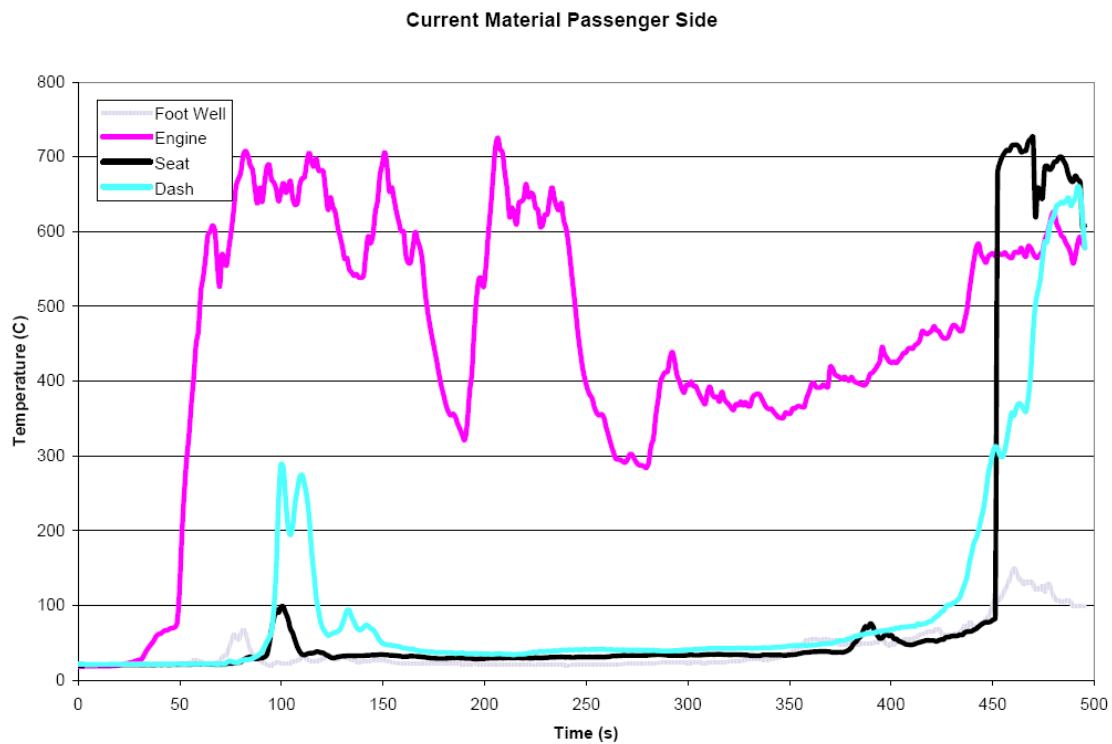
**Figure 4.28. Current Material Passenger Side Temperature Results**

Figure 4.28 shows the passenger side temperatures measured in the Current Material vehicle fire. As can be assumed, engine compartment temperatures are highest for most of the test. The spike in seat temperature at approximately 455 seconds is related to the entry of flames into the passenger compartment; this will be discussed further in the results section.

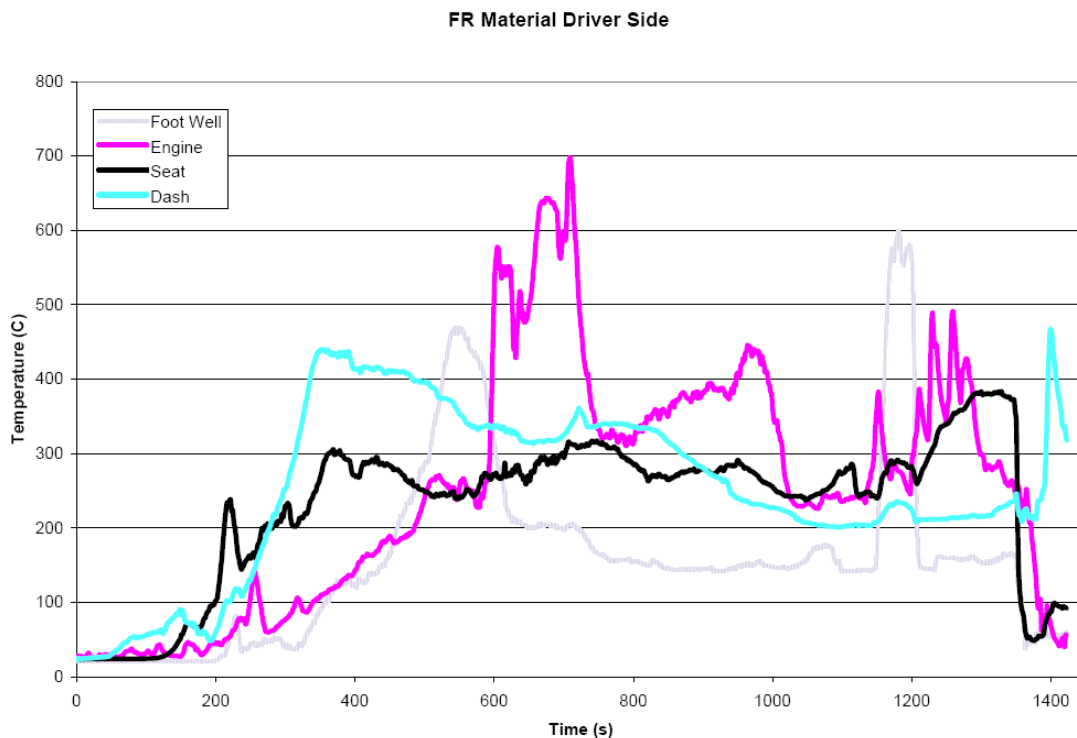
**Figure 4.29. FR Material Driver Side Temperature Results**

Figure 4.29 shows the driver side temperatures measured in the FR Material vehicle fire. These results exhibit more variation than the Current Material results; this can possibly be attributed to the difference in flame propagation [as compared to the Current Material test] through the engine compartment caused by the high winds. From the temperatures, it is clear that flames and heat found their way into the driver side of the passenger compartment resulting in high footwell and seat temperatures. This will be discussed further in the results section.

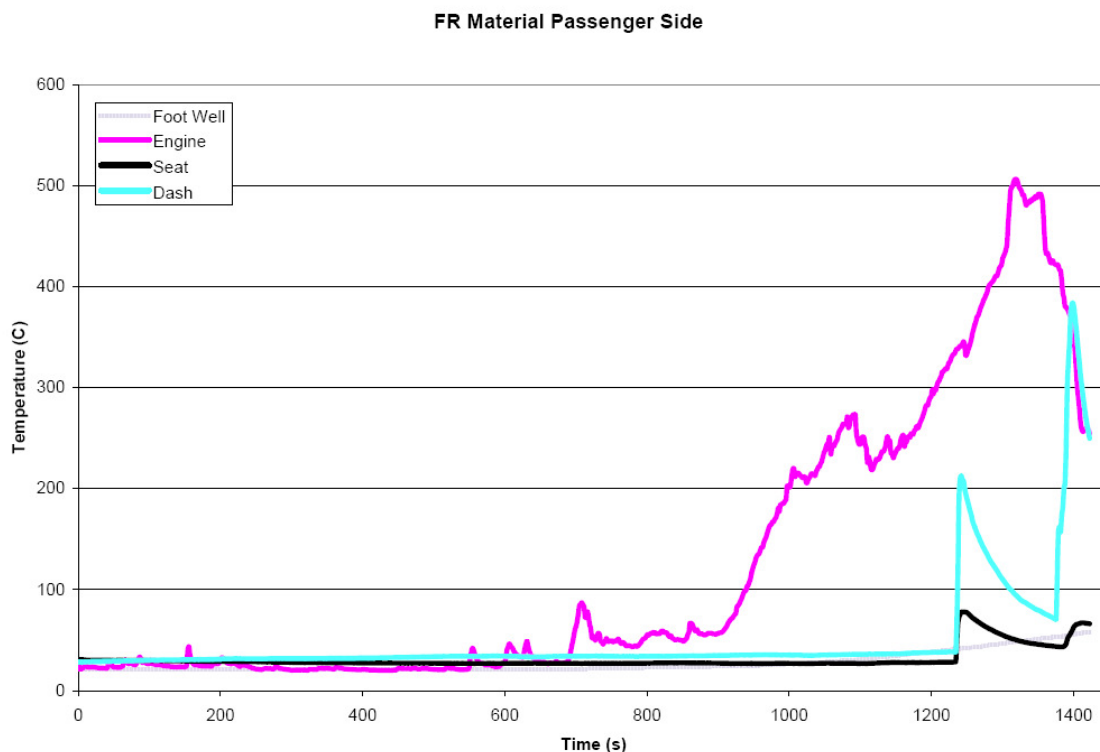
**Figure 4.30. FR Material Passenger Side Temperature Results**

Figure 4.30 shows the passenger side temperatures measured in the FR Material vehicle fire. Engine compartment temperatures are highest. The dashboard and seat temperatures both exhibit odd behavior; the readings are low until 1215 seconds where spikes occur in both, followed by a gradual decay period, then another spike in temperature at 1395 seconds. Individually, these results could be questioned because of their odd shape, but because they both follow the same pattern, their shape can possibly be attributed to flame entry into the passenger compartment. As discussed further in the results section, flames were observed entering the passenger compartment, supporting this hypothesis.

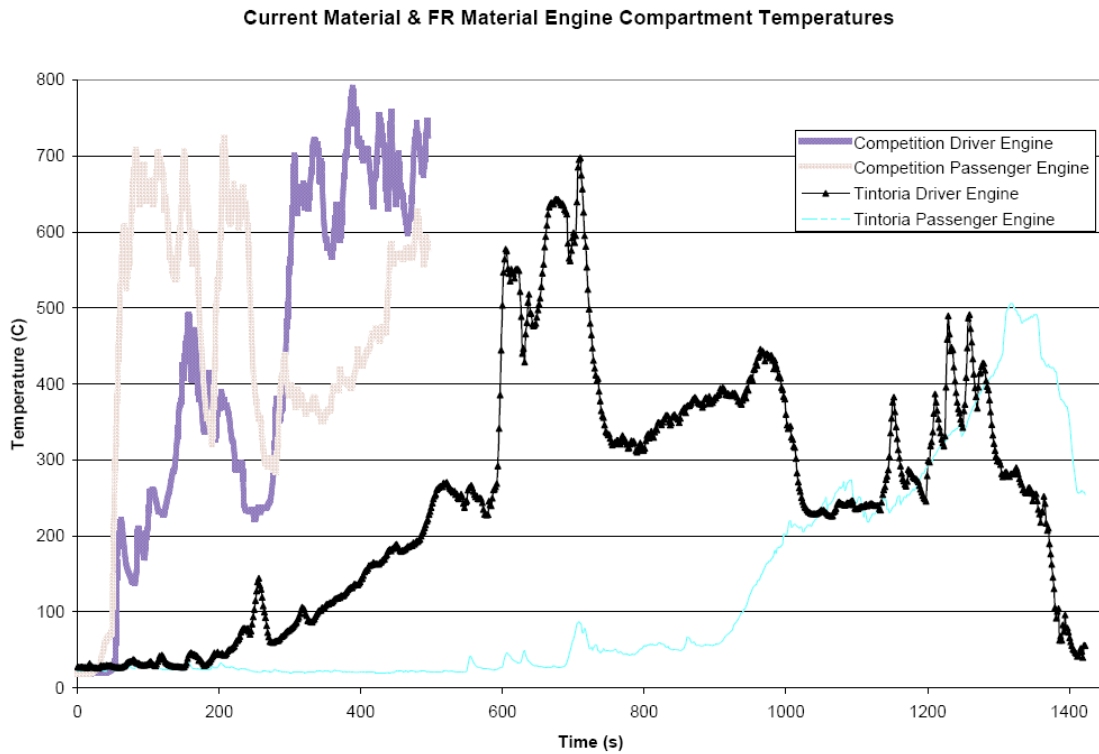
**Figure 4.31. FR Material and Current Material Engine Compartment Temperatures**

From Figure 4.31, the temperature results show that the engine compartment measurements for the Current Material burn are fairly similar to one another in the medial direction (engine to passenger compartment). They begin peaking within a minute of each other; this delay can be associated with the packing of the Excelsior as well as the size and orientation of the engine. The FR Material test, on the other hand, does not correlate well in the medial direction. Although the two plots share very similar shape, the driver side engine thermocouple begins its ascent at around 200 seconds while the passenger engine thermocouple begins its ascent at around 650 seconds. It is interesting that they share similar shape, which would indicate similar flame propagation; nearly eleven (11) minutes would pass before flames reached the passenger engine thermocouple. One explanation could be the wind effects; if the winds were impacting the vehicle toward the driver side of the vehicle, more air would be made available to the driver side, increasing fire size and thus temperatures.

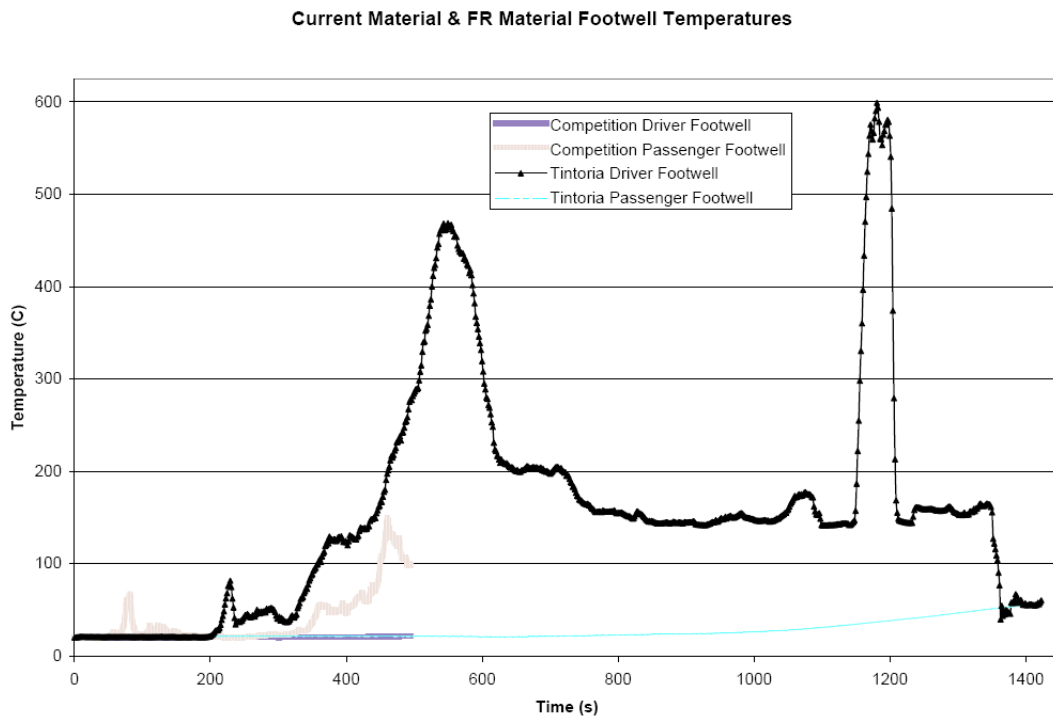
**Figure 4.32. FR Material and Current Material Footwell Temperatures**

In the Current Material test, due to the open door, a rise in footwell temperature was observed while the driver side footwell showed little if any increase in temperature, shown in Figure 4.32. The increase in the footwell temperature can be expected due to the flame travel through the open door. For the FR Material test, flames were seen flashing through the footwell and underside of the dashboard. From the post-fire photograph shown in Figure 4.33, it is clear that high temperatures resulted in the footwell by the presence of charred and melted material. Unfortunately, the temperature data does not correlate to this observation. Flames were able to penetrate the firewall, though, perhaps indicating that the lack of insulation coverage played a role.

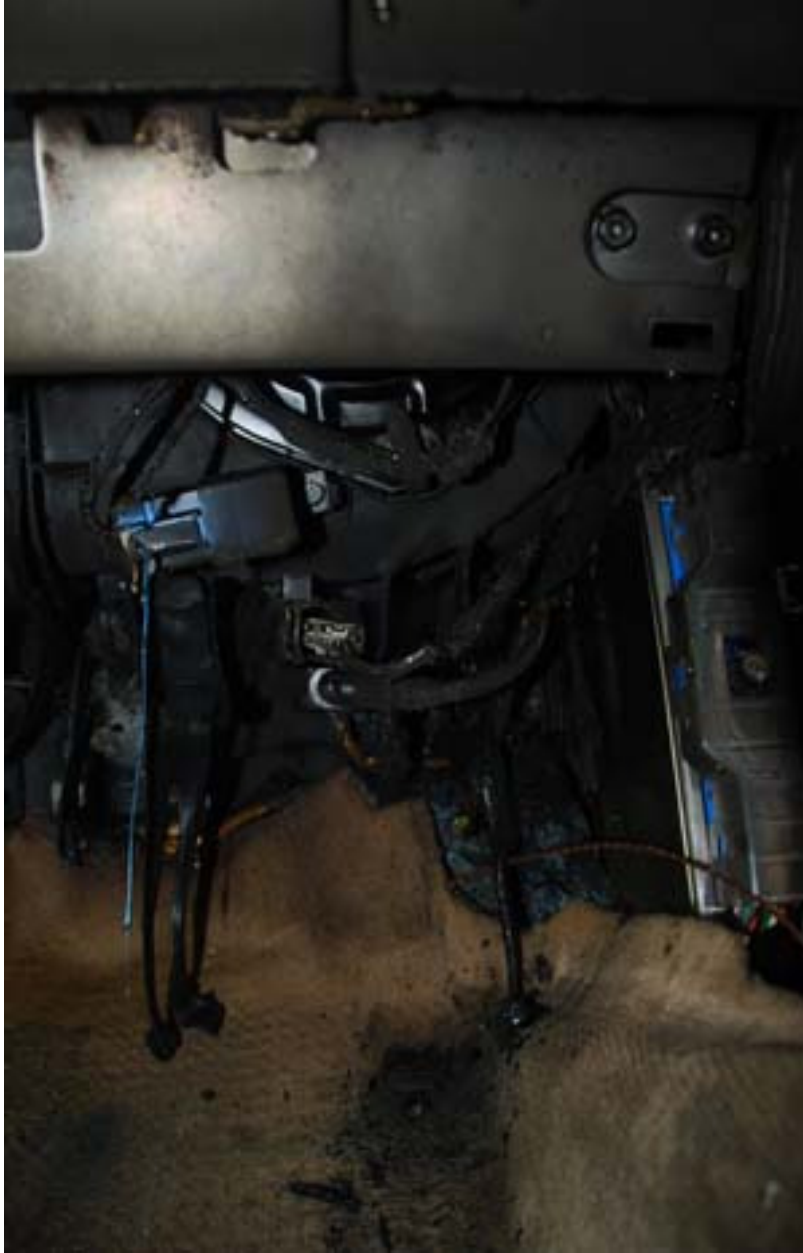
**Figure 4.33. Post-fire damage to FR Material passenger footwell after flame penetration**

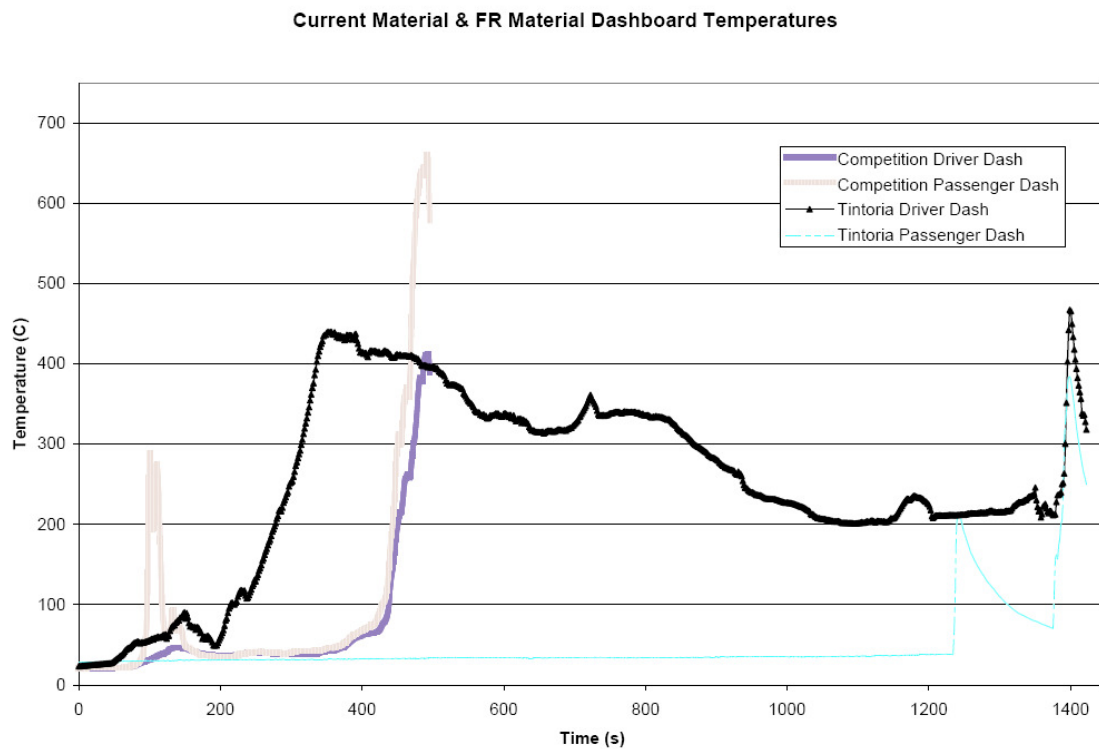
**Figure 4.34. FR Material and Current Material Dashboard Temperatures**

In Figure 4.34, the temperature profiles of the Current Material dashboard follow each other very closely. The spike of the passenger side thermocouple at 90 seconds could be indicative of the flames leaping around the door jam into the passenger compartment just under the windshield. Then as the engine fire becomes more involved, the windshield and the area just inside above the dashboard begin to heat up. This can be seen as the two plots follow the same path at 380 seconds and on. The windshield was cracked by this point, as shown in Figures 4.35 and 4.36, allowing even more heat into the region above the dashboard. Then at approximately 415 seconds, the passenger dashboard temperature begins its steeper rise than the driver side dashboard. This can be related to the open door allowing more heat to enter the vehicle by means of the passenger side. In the FR

Material test, the dashboard temperature begins its ascent at about 220 seconds, continuing until approximately 360 seconds where it begins a slow reduction in temperature for most of the rest of the test. The passenger dash registers little rise in temperature for most of the test until two spikes near the end of the test.

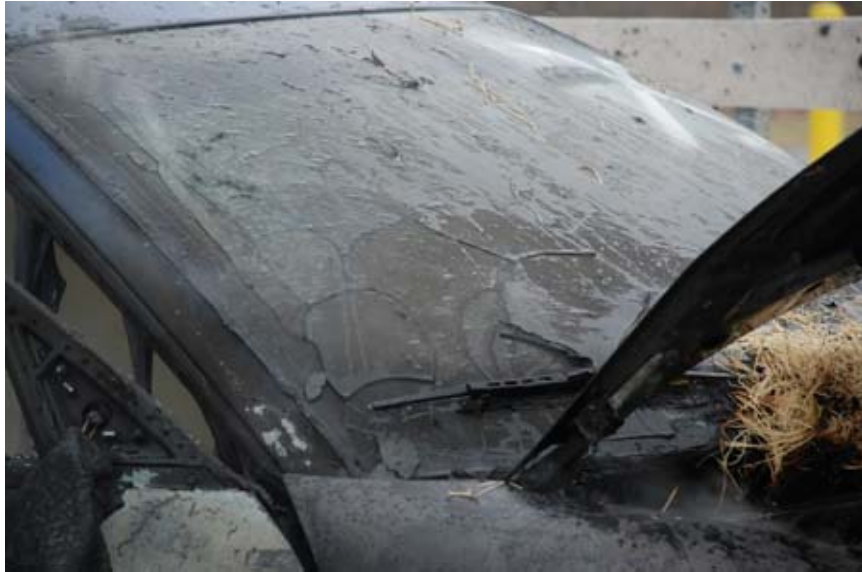
**Figure 4.35. Cracked windshield on Current Material post-fire**

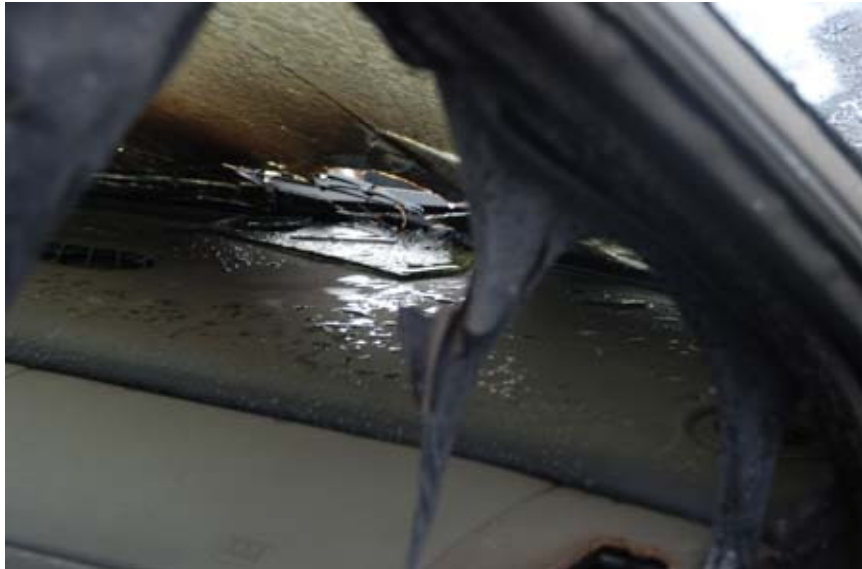
**Figure 4.36. Crack windshield interior view on Current Material post-fire**

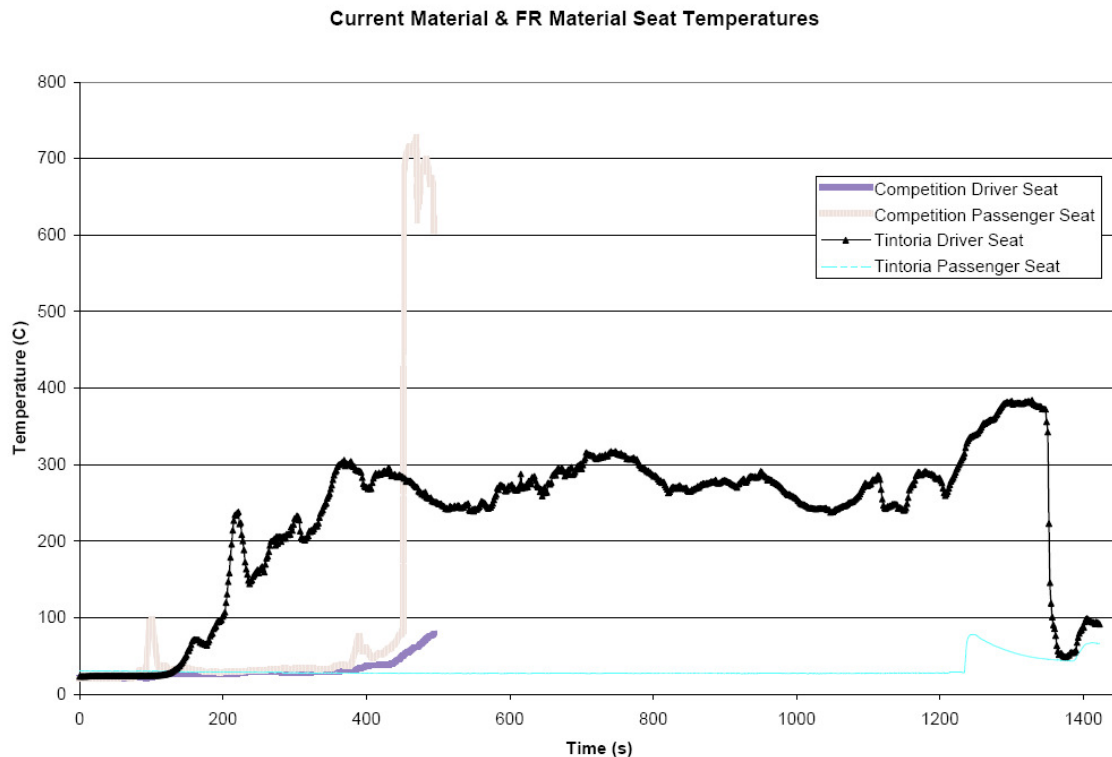
**Figure 4.37. FR Material and Current Material Occupant Seating Area Temperatures**

The readings in Figure 4.37 for the occupant seating areas are fairly similar for both tests for most time periods, other than the FR Material driver seat. A pattern observed in the FR Material tests is the high temperatures recorded on the driver side of the vehicle. An observer noticed that flames appeared to have flashed through the AC vent on the driver side; even if these flames only passed through once, it is still apparent that a large amount of heat must be traveling through penetrations in the dashboard. This could account for the high temperatures in the driver side dash and footwell, with peaks at about 450 C; the peak of the seat was only 310 C, which is reasonable because of its distance from the footwell and the dash. The Current Material peaks to 100 C at about 100 seconds, which can be associated with the flames entering through the door. The peak at 450 seconds matches the peaks in other graphs as well.

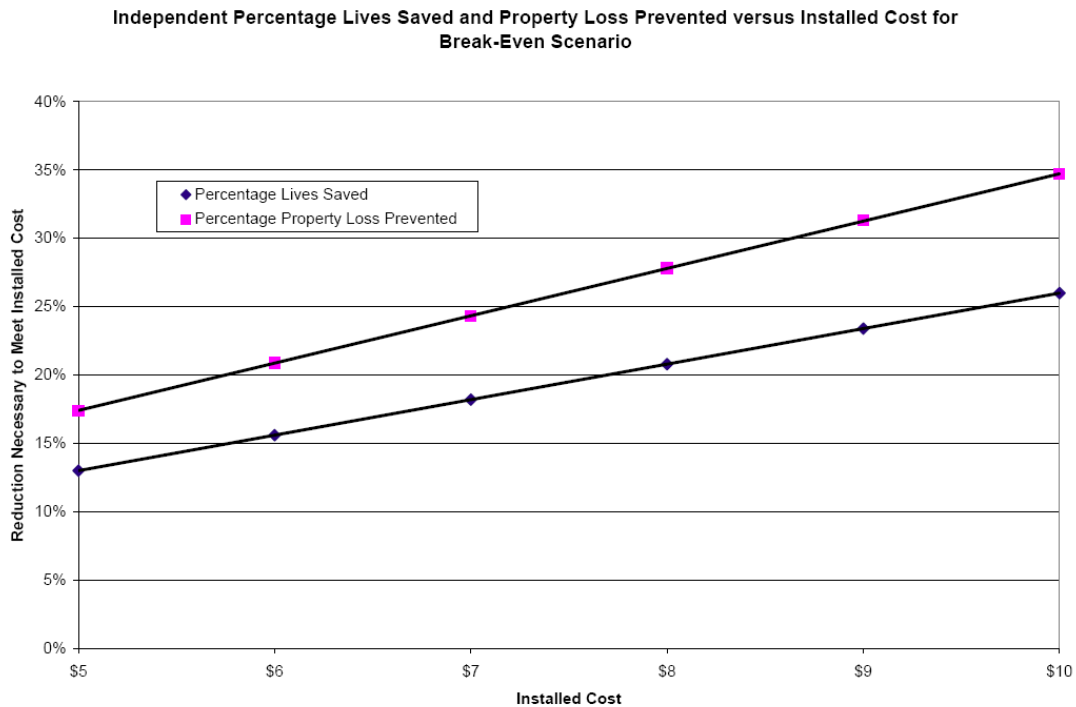
**Figure 4.38. Independent Property Loss and Death Reduction Percentages versus Installed Cost**

These results indicate that at the minimum installed cost of \$5, a 13.0% reduction in deaths and a 17.4% reduction in property loss would need to be achieved in order to meet the total installed cost. At the maximum installed cost of \$10, a 26.0% reduction in deaths and a 34.7% reduction in property loss would need to be achieved in order to meet

the total installed cost. A plot of these values with linear trendlines is shown in Figure 4.38.

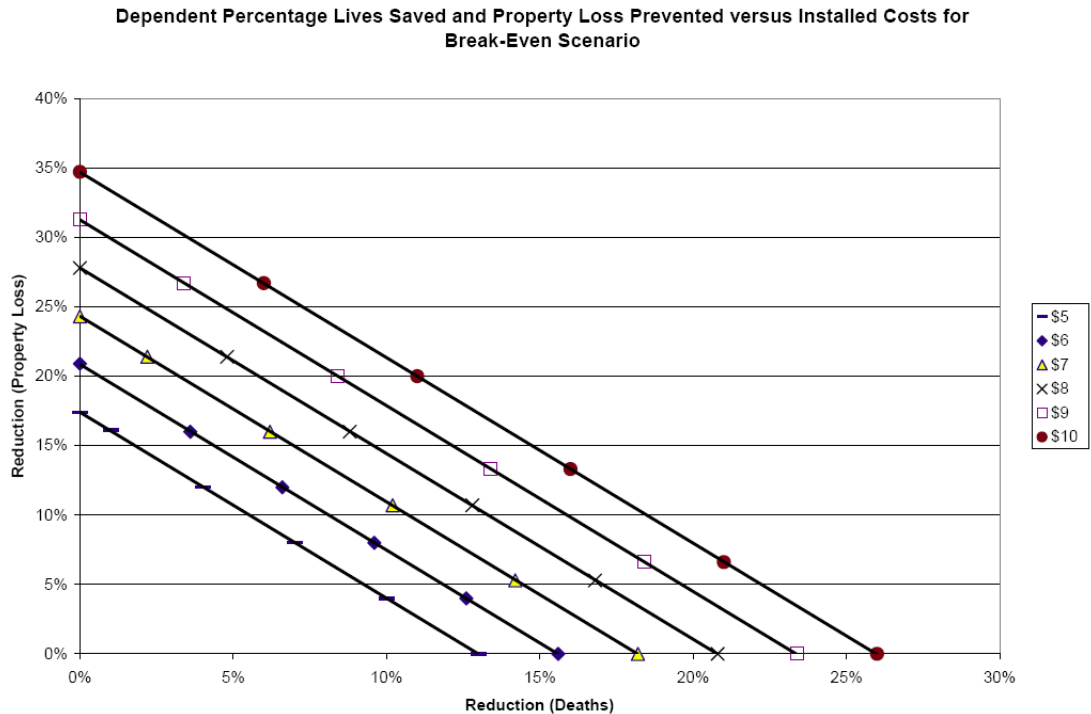
**Figure 4.39. Dependent Property Loss and Death Reduction Percentages versus Installed Cost**

This data is incomplete, though, because in vehicle fires both property and lives will be saved by the installation of the FR Material. In order to determine what combinations of percentages equalize the benefits and costs, the maximum reduction percentage in deaths for a particular installed cost was plotted against 0.0% property loss and vice versa for the maximum reduction percentage in property loss. This was performed for each installed cost and the results are shown in Figure 4.39.

From Figure 4.39, each trendline gives coordinating percent reduction values for both benefits in order to equalize benefits and costs. This provides an opportunity to examine the feasibility of each installed cost and the possible reduction percentages that can apply. Based on this data, an installed cost of \$5 per car would require the least reduction in property loss and deaths, but the \$5 install cost is the bare minimum cost and a more realistic cost should be selected. Although the FR Material manufacturer stated that an installation cost of \$5.00 is possible for some vehicles, not every vehicle will fall into this cost. The \$8 cost was selected under the assumption that it best represents the average cost of installation; this was assumed because of the trends of larger car use in the U.S. currently. At \$8, the plot requires that at 11% reduction in deaths, a 13.1% reduction in property loss is necessary to equalize benefits and costs. These values will be considered in the final analysis of the FR Material.
