## PERFORMANCE VERIFICATION STATEMENT for the YSI 6-series sonde with model 6560 Salinity Sensor

<b>TECHNOLOGY TYPE:</b>	Coupled conductivity and temperature sensors with instrument based algorithms for estimation of salinity
<b>APPLICATION:</b>	In situ estimates of salinity for coastal moored and profiled deployments
<b>PARAMETERS EVALUATED:</b>	Response linearity, accuracy, precision and reliability
<b>TYPE OF EVALUATION:</b>	Laboratory and Field Performance Verification
<b>DATE OF EVALUATION:</b>	Testing conducted from May through October 2008
<b>EVALUATION PERSONNEL:</b>	S. Gilbert, K. Gundersen, T. Johengen, T. McKissack, M. McIntyre, A. Pinchuk, H. Purcell, C. Robertson, D. Schar, G.J. Smith, M. Tamburri and D. Wells.

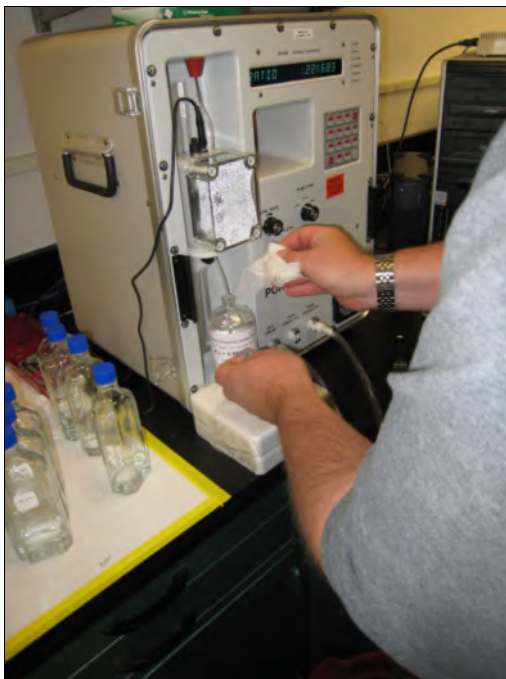
**Figure 1.** Analytical instrumentation (Portasal 8410A) used for laboratory analysis of salinity reference samples and one of the test baths and instrument racks used for the laboratory tests.

Laboratory tests focused on verifying the manufacturers' stated performance characteristics of accuracy and precision using controlled laboratory settings to obtain the highest degree of accuracy and precision for corresponding reference standards. The instrument package was tested at five different salinity levels including 35, 30, 25, 16 and 6 on the practical salinity scale (PSS-78; 60 to 6 mS/cm conductivity), each at three different temperatures including 32 °C, 16 °C and 6 °C. The instrument was pre-equilibrated to the controlled bath test conditions for 60 minutes prior to the start of reference sampling. The instrument was set to measure in situ conductivity and temperature using its own algorithms to derive a practical salinity estimate from these values at 1-minute intervals. Ten reference water samples were collected at sensor depth into sealed pre-rinsed glass salinity bottles at 3 minute intervals over 30 minutes. Each reference sample set was stored at room temperature and analyzed after 24 hours on the Portasal 8410A (Fig. 1).

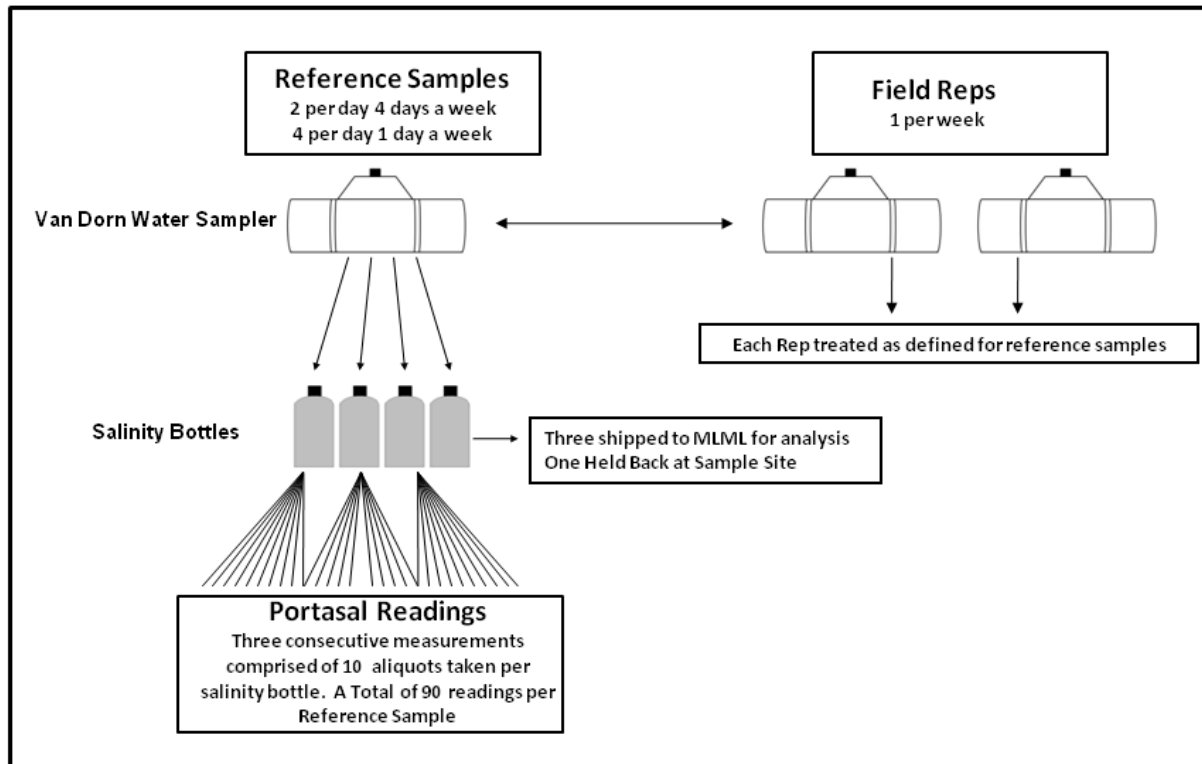
**Figure 2.** Schematic representation of the reference sampling process conducted during moored deployment field tests.

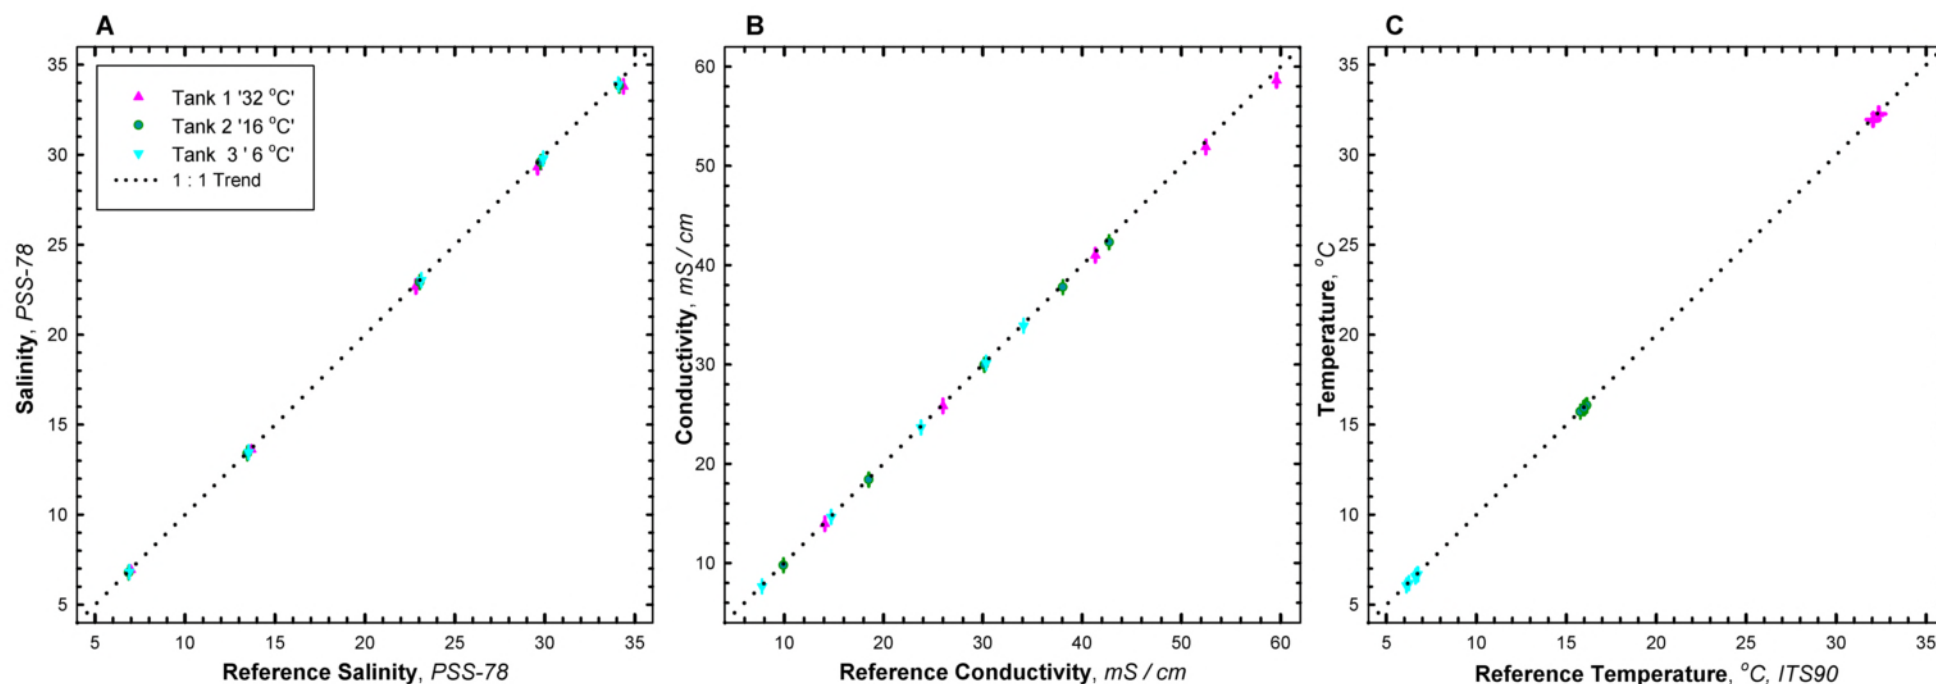
**Figure 3.** Evaluation of the response linearity for YSI's 6600 Sonde conductivity and temperature sensor package during controlled laboratory exposures to a combination of natural seawater dilutions and temperatures. Consecutive test exposures ranged between 35 to 6 on the practical salinity scale (PSS-78; 60 to 6 mS/cm conductivity) and 33 to 6 °C. [A] Correspondence of instrument derived salinity to Portosal reference measurements; [B] Correspondence of instrument in situ conductivity measurement to conductivity estimate derived from the Portosal salinity and reference temperature measurement by inversion of the seawater equations of state (IAPSO PSS-78); [C] Correspondence of instrument temperature measurement to bath reference temperature recorded by a calibrated RBR 1060 logging thermometer. Data points are represented as mean  $\pm$  standard deviation of and 10 reference water samples. Dotted lines represent 1:1 ideal correlation of measures.

Analyzed across all five salinity levels and all three temperatures, the YSI 6600 exhibited a strong linear response to the test solutions with  $R^2 > 0.9999$ , a standard error = 0.1015 and a slope = 0.991 (Fig. 3). Most of variability was observed in the conductivity measurements which had a regression standard error of 0.125 compared to only 0.003 for the temperature sensor responses. The variance in 30 repeated measurements taken at one minute intervals for each of the laboratory trials is shown in Figure 4. The plots are not a measure of engineering precision as environmental conditions within the test baths did change during the sampling process. The variation in instrument derived measurements is plotted relative to the average standard deviation and 3-times the standard deviation upper specification limit of reference salinity, conductivity, and temperature measurements taken over corresponding time intervals for all lab tests. An alternative version of this figure showing a direct comparison of instrument versus reference sample variance for each individual trial is given in Appendix 1. Instrument offsets in salinity, conductivity and temperature were computed for each test run as the difference in the mean instrument measure from the mean reference measure for that test bath condition (Fig. 5). There was an increase in conductivity measurement error and consequently salinity offset, as the salinity of the test solutions increased. The temperature sensor also should an increased offset as test temperatures increased. The average of the measurement offsets across all 15 lab tests were -0.1678 psu for salinity, -0.2732 mS/cm for conductivity, and -0.0737 °C for temperature.

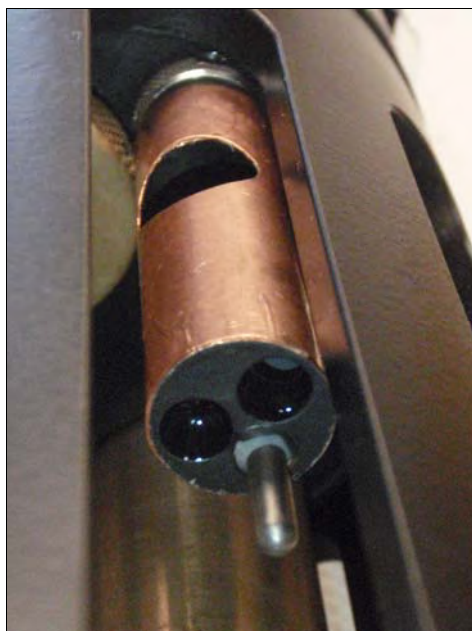
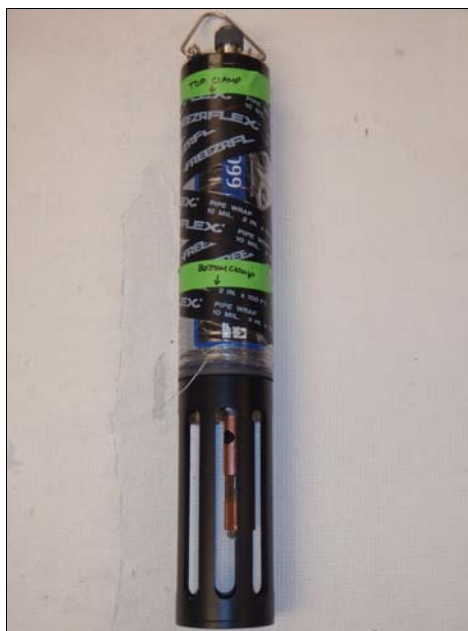
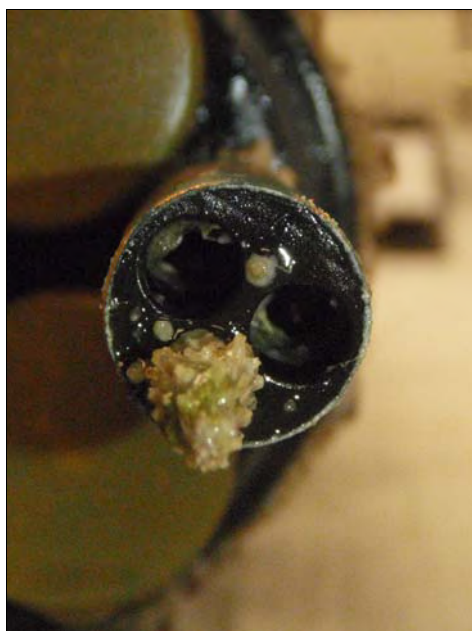
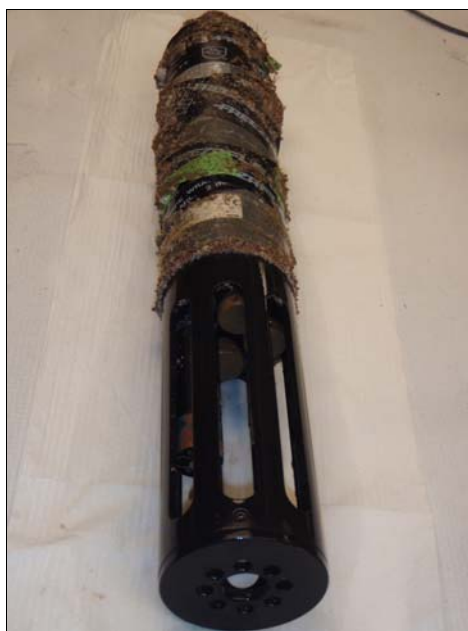
Before and after photos were taken of the instrument to examine the extent and possible impacts of bio-fouling (Fig. 10). A significant amount of hard, encrusting bio-fouling was evident across most of the instrument body by the end of the deployment, including some directly within the conductivity cell despite the application of copper tape on the outside of the sensor.

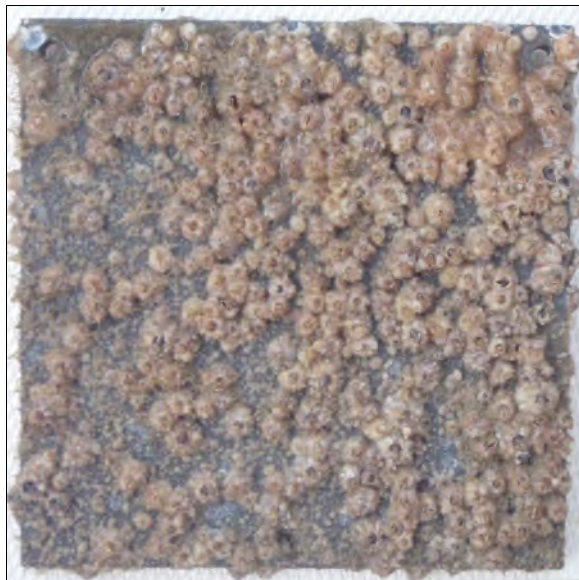
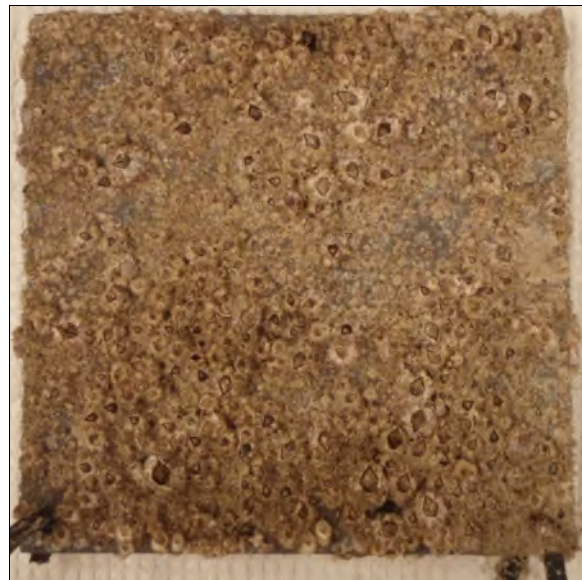
Bio-fouling plates were retrieved and photographed once each week throughout the deployment to help define the rate and extent of biofouling within the test environment (Fig. 11). By the third week of deployment there was an extensive amount of hard, encrusting biofouling at the Florida test site.

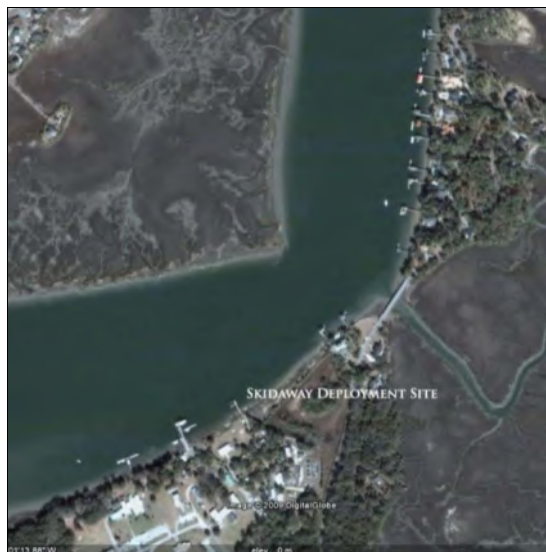
**Figure 12.** Site map and deployment arrangement for the field test conducted at Skidaway Island in Savannah, GA.

The mooring test in Georgia took place on a floating dock located on Skidaway Island on the Skidaway River (Fig. 12). The water depth of the test site was 2.3 m at minimum. The site exhibited a fairly large fluctuation in salinity, ranging from 26 – 33 PSU, and temperatures ranged from 28 – 31 °C.

SkIO Deployment Site off Skidaway Island

SkIO Easy Dock with Rack in Center

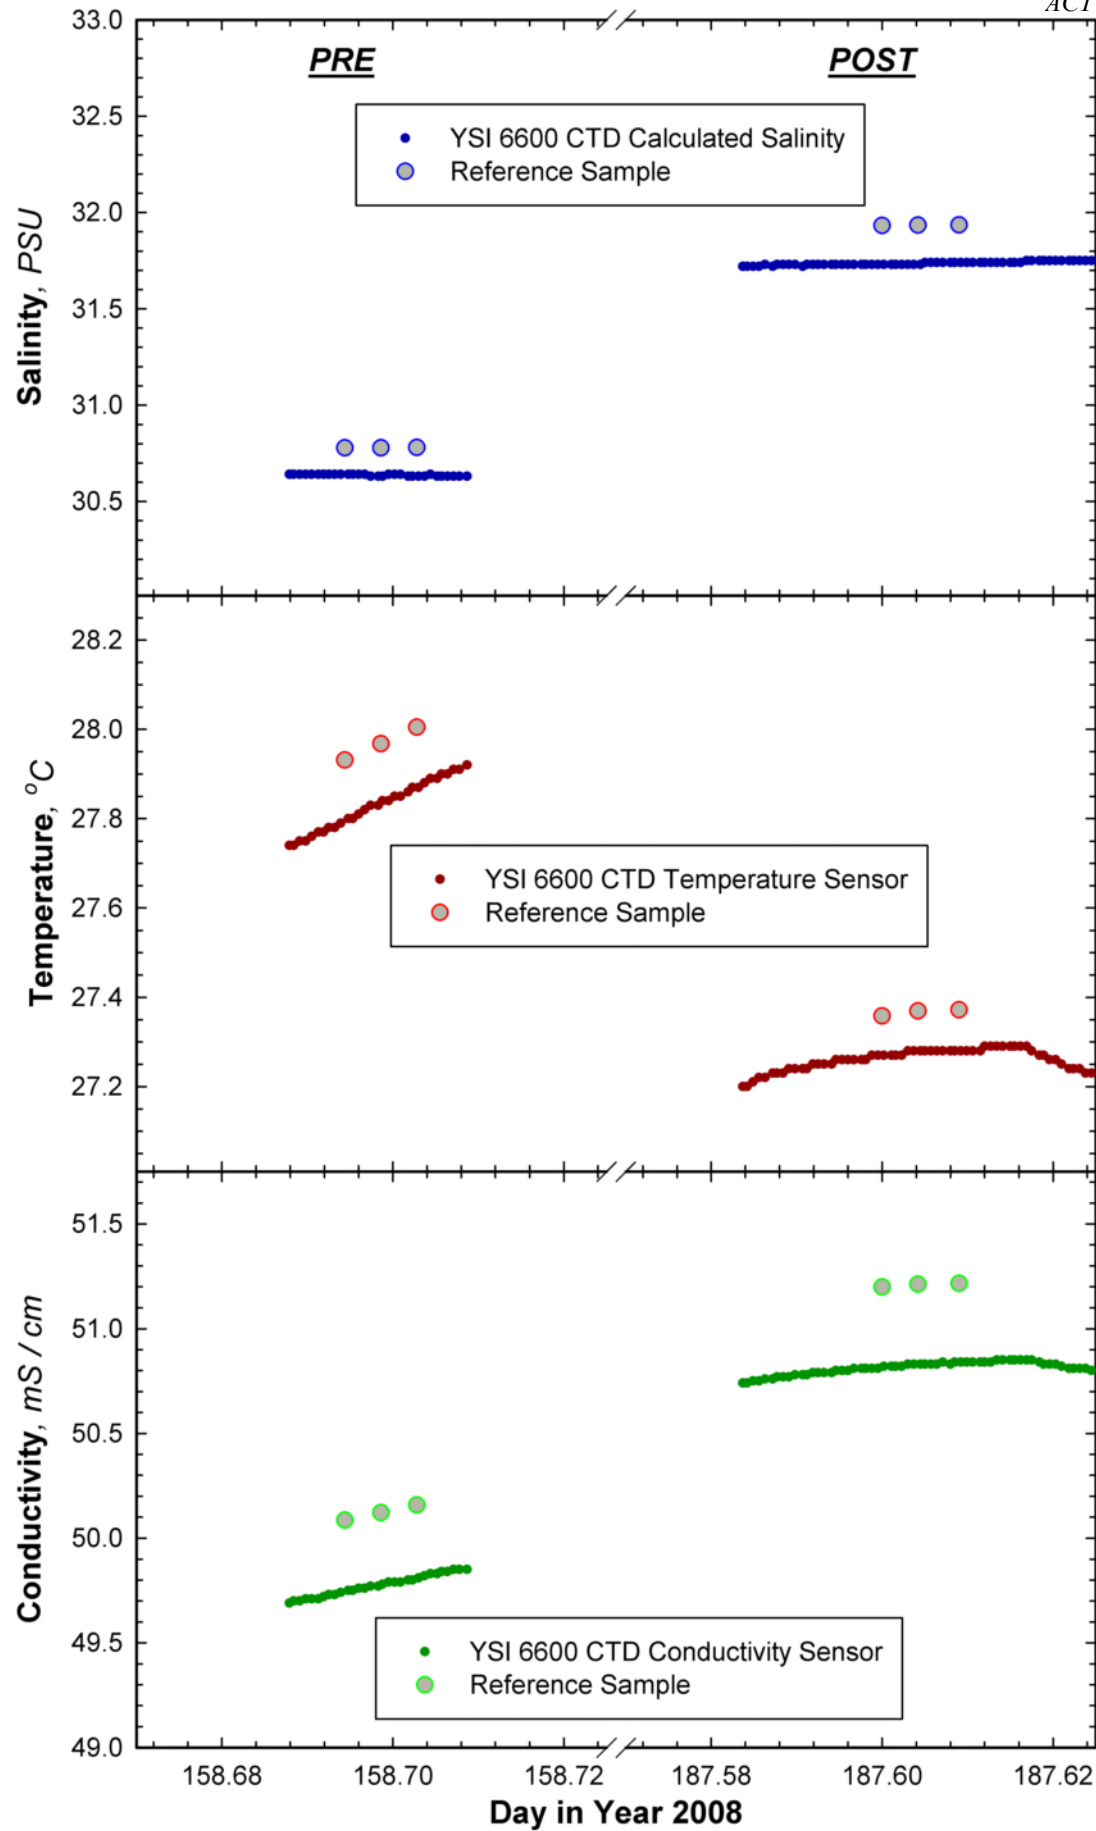
**Figure 15.** Pre- and Post-deployment reference checks in tanks of natural seawater at SkIO. Post-deployment tests conducted after cleaning instrument of all fouling material according to manufacturer's recommendations.

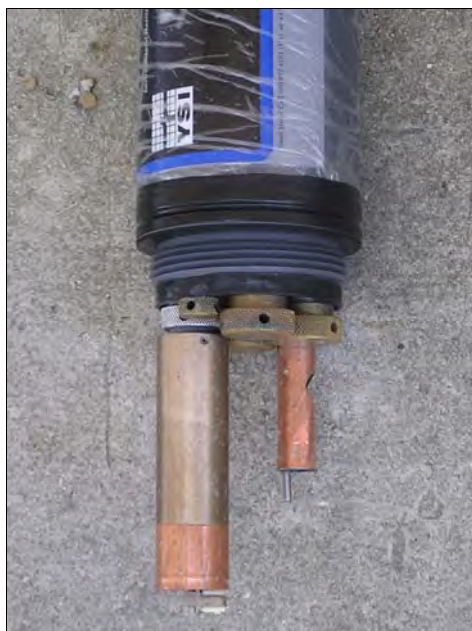
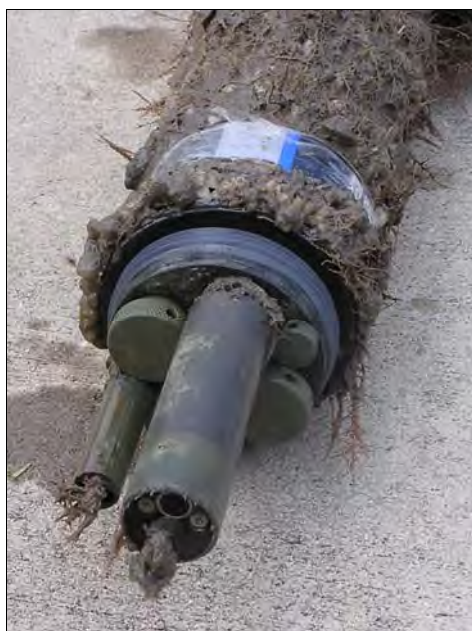
Before and after photos were taken of the instrument to examine the extent and possible impacts of bio-fouling (Fig. 16). A significant amount of soft (plant material) and hard (calcified) bio-fouling was evident across most of the instrument body by the end of the deployment. The copper tape on the sensors reduced the extent of fouling but appeared to get within the opening of the conductivity cell itself.

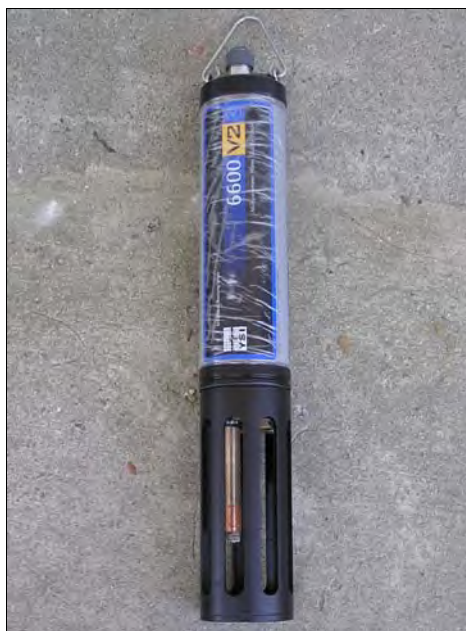
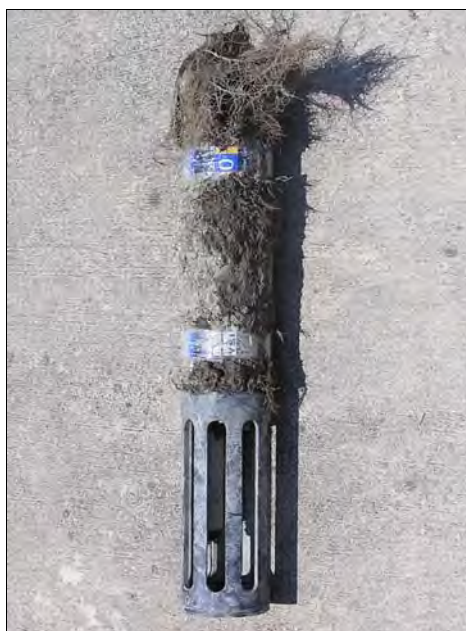
**Figure 16.** YSI 6600 instrument photos from Skidaway, GA test site before and after deployment.

Prior to Deployment (Full View)

After Deployment (Full View)

Time series data of in situ measured conductivity and temperature, and derived salinity, for the GA field test were plotted against corresponding results from the laboratory analyzed reference samples and reference temperature logger (Fig. 13). The initial calibration of the sonde was much better at this site and the error in salinity measurements over the first 2 weeks ranged from -0.203 to 0.217 psu. Once biofouling became extensive the amount of offset increased sharply with a maximum value of -2.1 psu (Fig. 14). The magnitude of the offset in instrument salinity measurements was clearly related to performance of the conductivity cell. The temperature sensor was stable throughout the deployment with an average offset of  $-0.093 \pm 0.033$  °C relative to the reference temperature logger. Results of the pre- and post-deployment exposure tests, after the instrument was cleaned to remove all biofouling, are shown in figure 15. The offsets in salinity measurements are similar, to within 0.1 psu, between the pre- and post-exposure tests with a slightly more negative difference in the post that may still be a cleaning issue. Temperature readings were also similar between pre and post and consistent with the field time series of being approximately -0.9 °C relative to the reference. The amount of biofouling that developed on the instrument during the deployment is shown in figure 16, and a time-series of biofouling rates on PVC tiles is shown in figure 17.

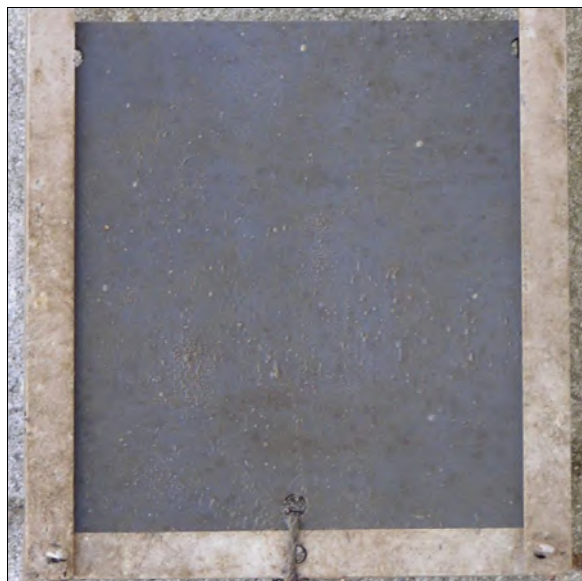
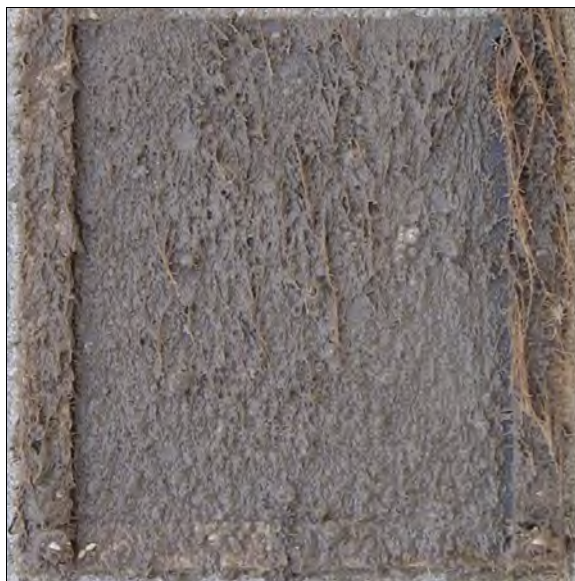
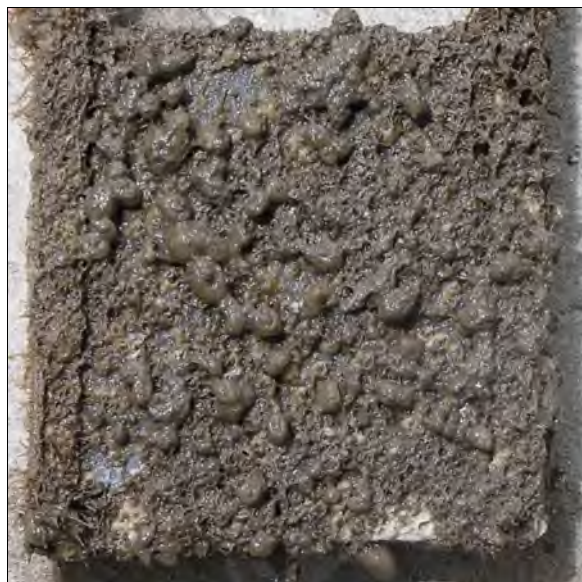
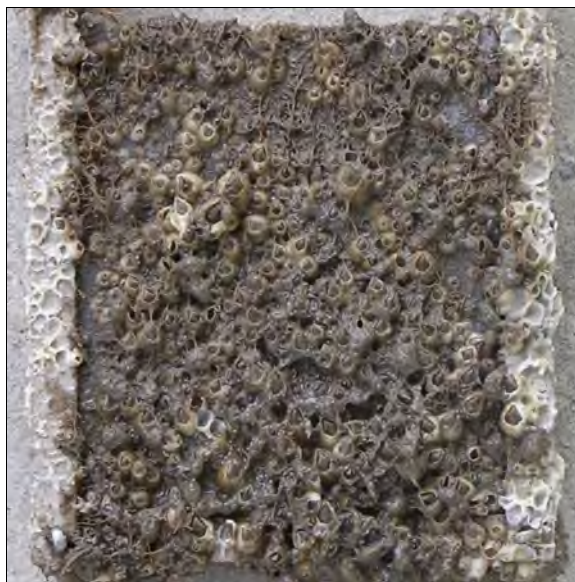
Bio-fouling plates were retrieved and photographed once each week throughout the deployment to help define the rate and extent of biofouling within the test environment (Fig. 17). Significant amounts of soft biofouling were evident by week 2 and progressed into heavy amounts of hard, encrusting biofouling at the Georgia test site.

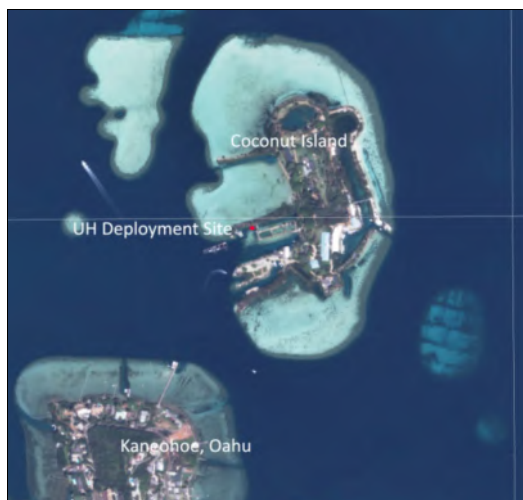
**Figure 18.** Site Photos from Field Deployment off Coconut Island, Kaneohe Bay, HI.

The mooring test in Kaneohe Bay took place on the fringing reef flat surrounding Coconut Island. The instruments were placed on a standing rack (Fig. 18) in a water depth of 3 meters with tidal variations typically less than 0.5 m at this site. During the deployment test, salinity values ranged from 33 to 35.5 and water temperatures from 26.1 to 29.6 °C.

Deployment Site on Coconut Island

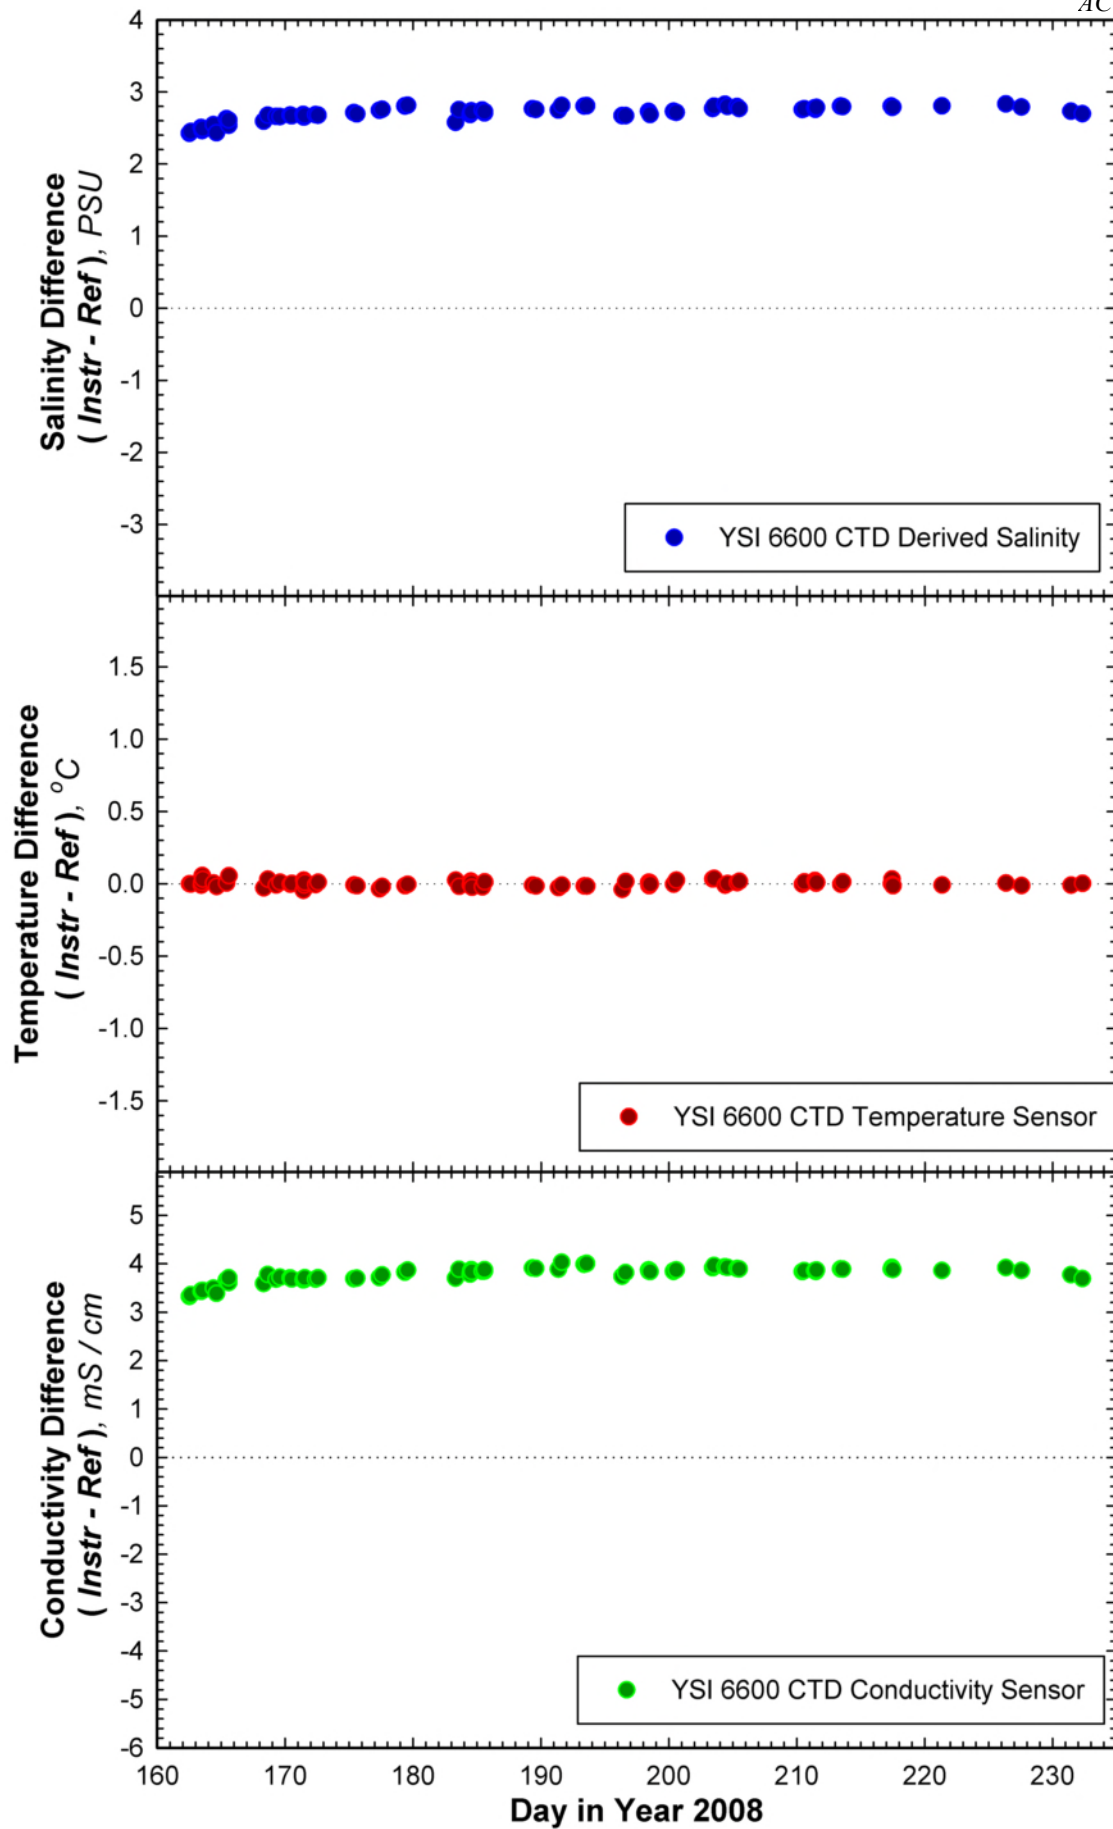
**Figure 20.** Assessment of relative accuracy of instrument time series measurements during the HI field deployment.

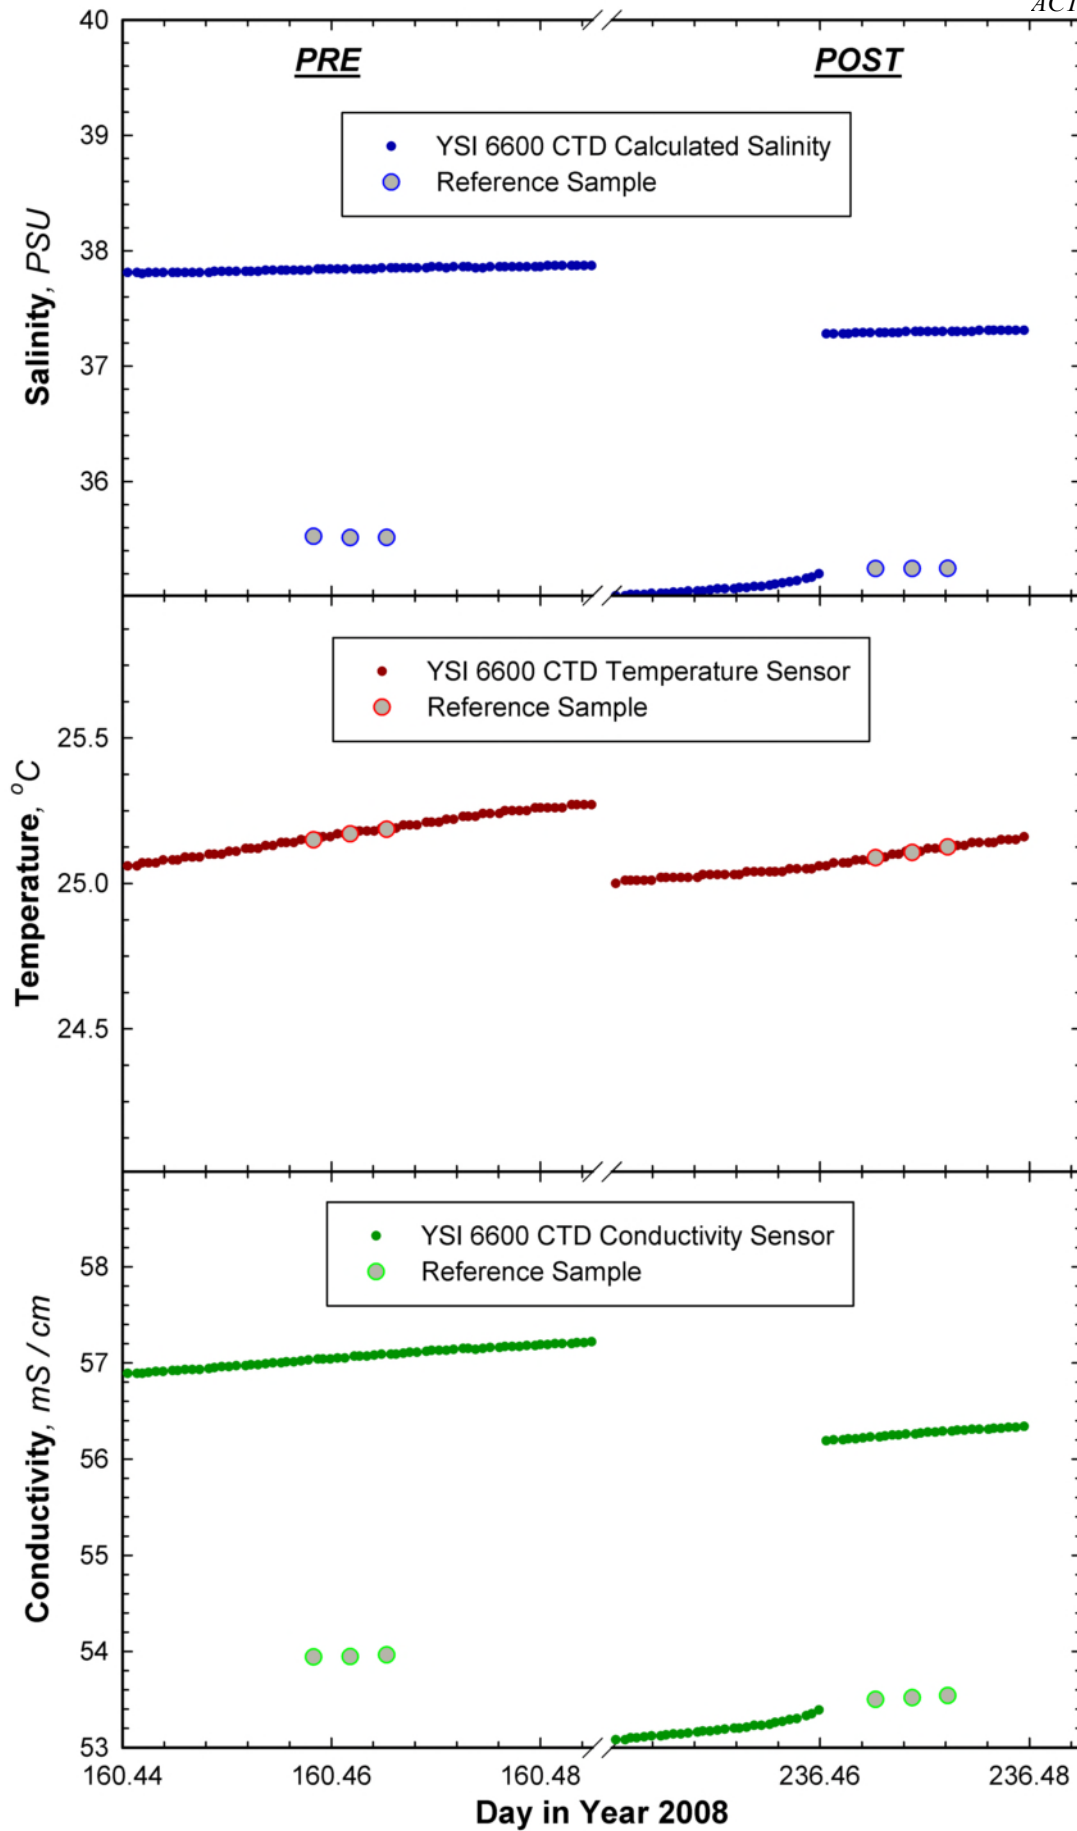
**Figure 21.** Pre- and Post-deployment reference checks in tanks of natural seawater at HI. Post-deployment tests conducted after cleaning instrument of all fouling material according to manufacturer's recommendations.

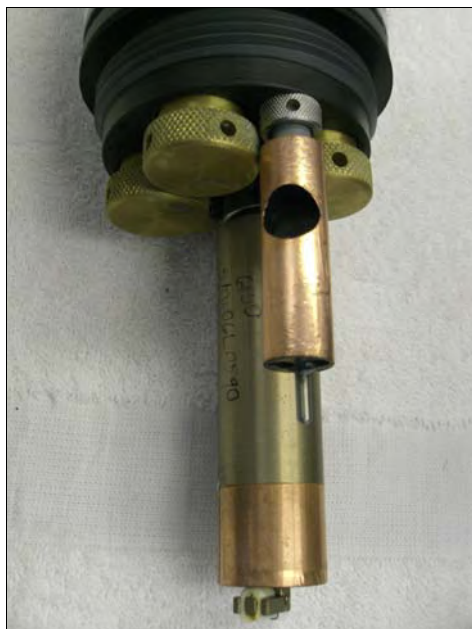
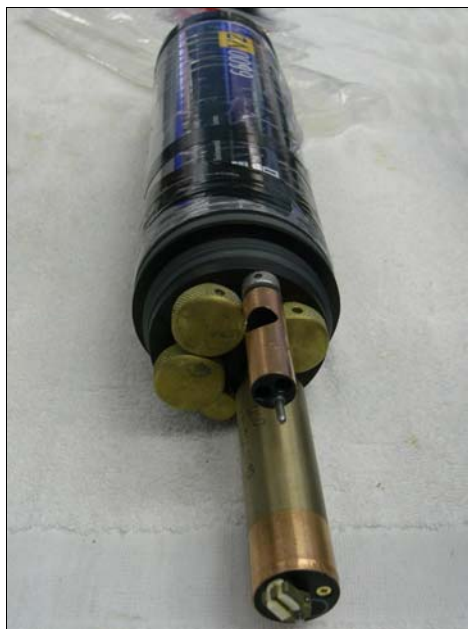
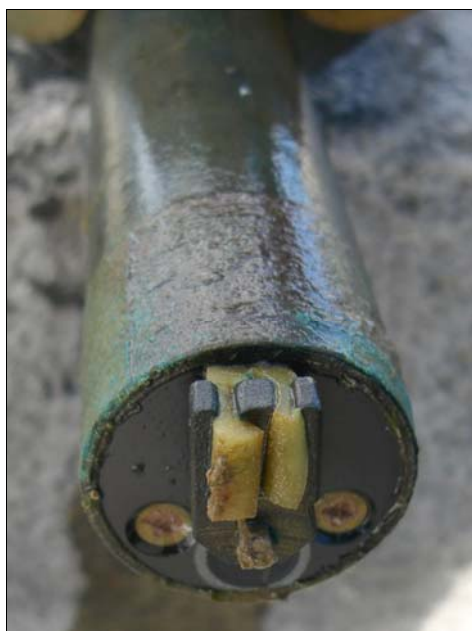
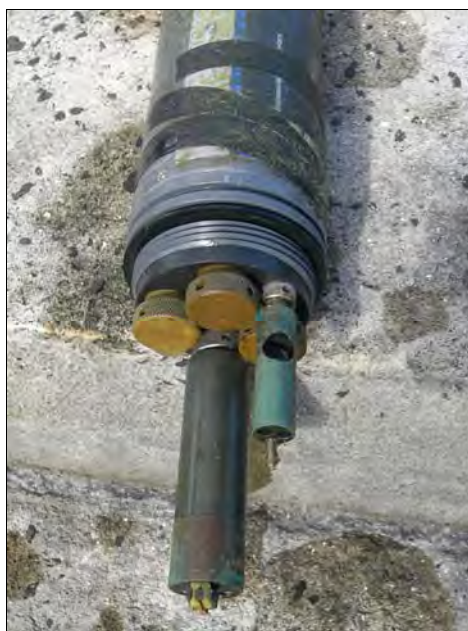
Before and after photos were taken of the instrument to examine the extent and possible impacts of bio-fouling (Fig. 22). The extent of bio-fouling was significantly less at this test site relative to FL or GA despite the longer deployment period and was mostly comprised of plant material and worm cases.

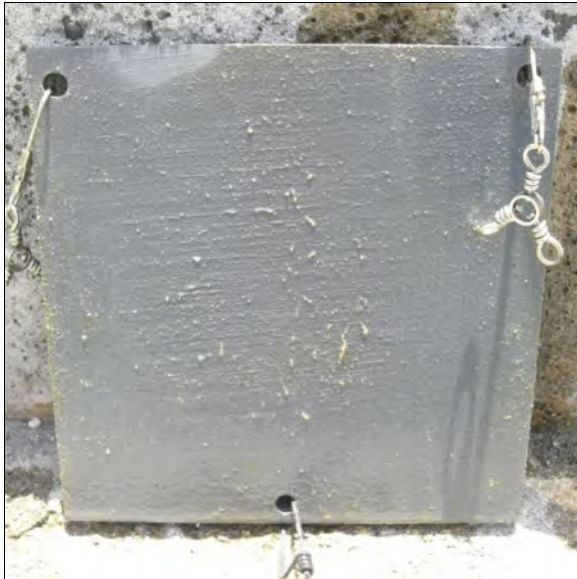
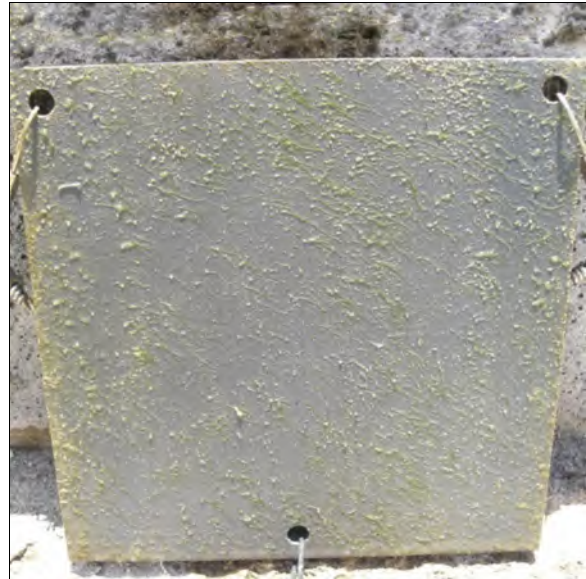
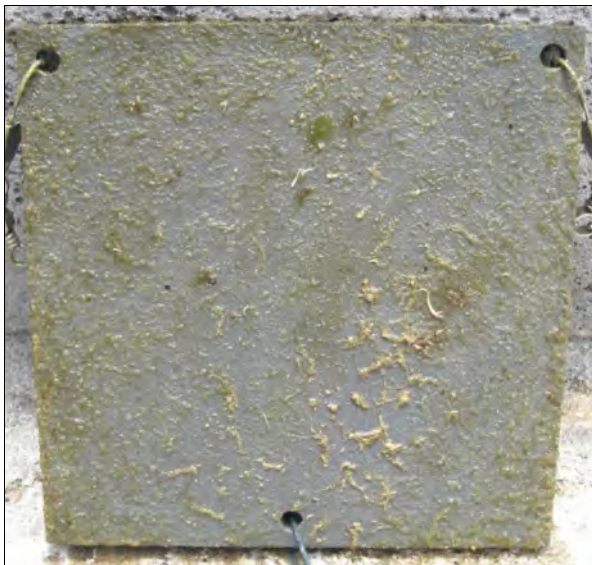
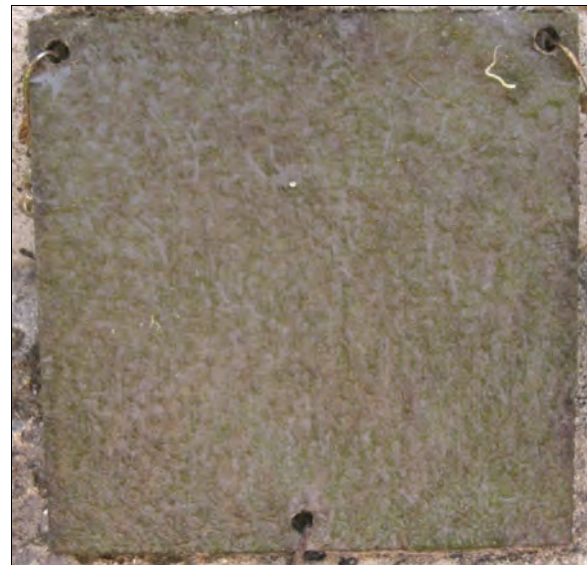
Bio-fouling plates were retrieved and photographed once each week throughout the deployment to help define the rate and extent of biofouling within the test environment. A subset of the plate photographs covering weeks 1, 2, 4, and 8 are shown in Figure 23. The extent of bio-fouling was significantly less at this test site relative to FL or GA despite the longer deployment period and was mostly comprised of plant material and worm cases.

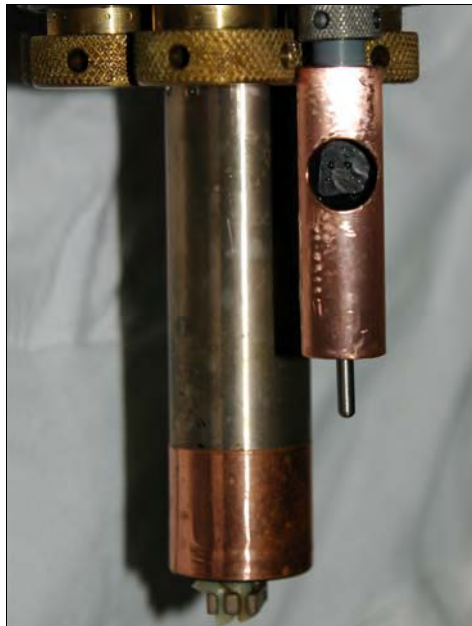
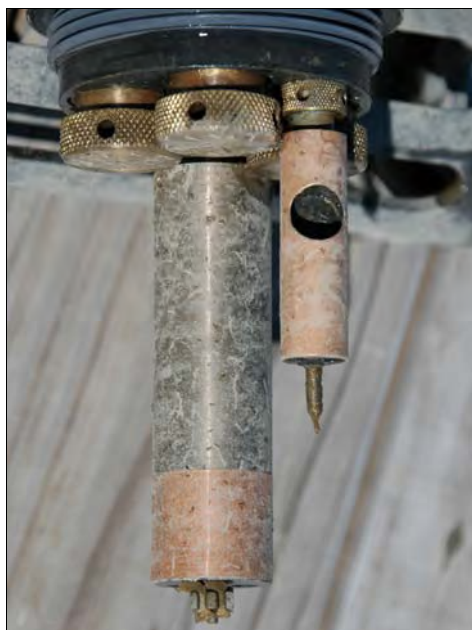
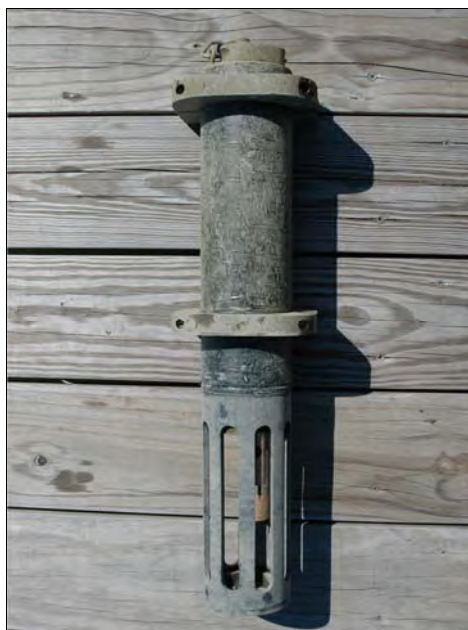
Before and after photos were taken of the instrument to examine the extent and possible impacts of bio-fouling (Fig. 28). The extent of bio-fouling was quite low at the MI test site and consisted of only soft plant material.

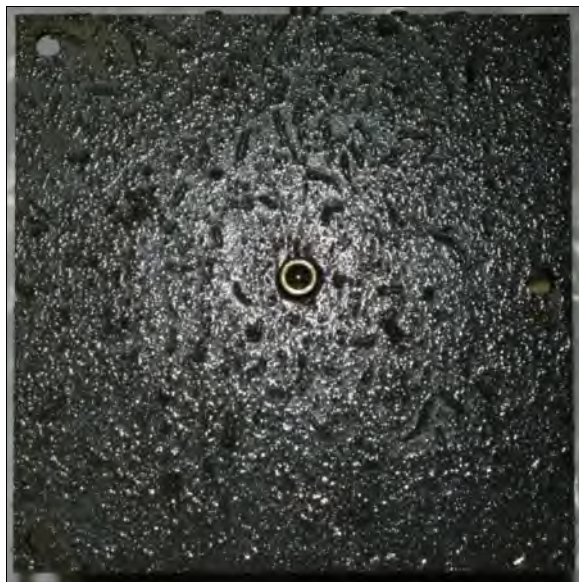
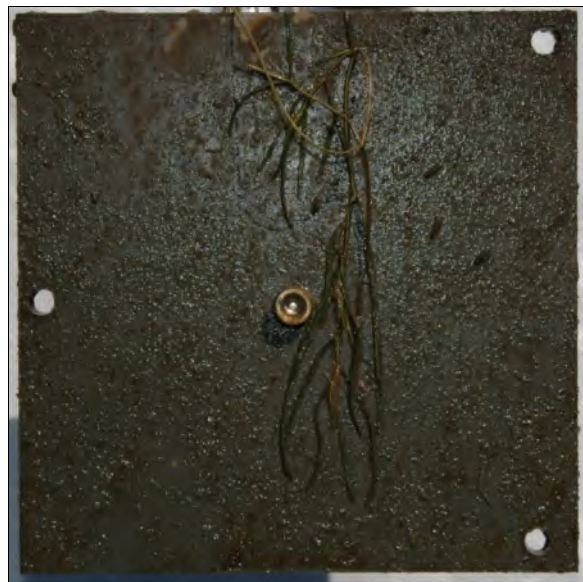
Bio-fouling plates were retrieved and photographed once each week throughout the deployment to help define the rate and extent of biofouling within the test environment (Fig. 29). Biofouling material was mostly comprised of plant material and developed rather quickly but did not appear to accumulate significantly once the original surface was covered.

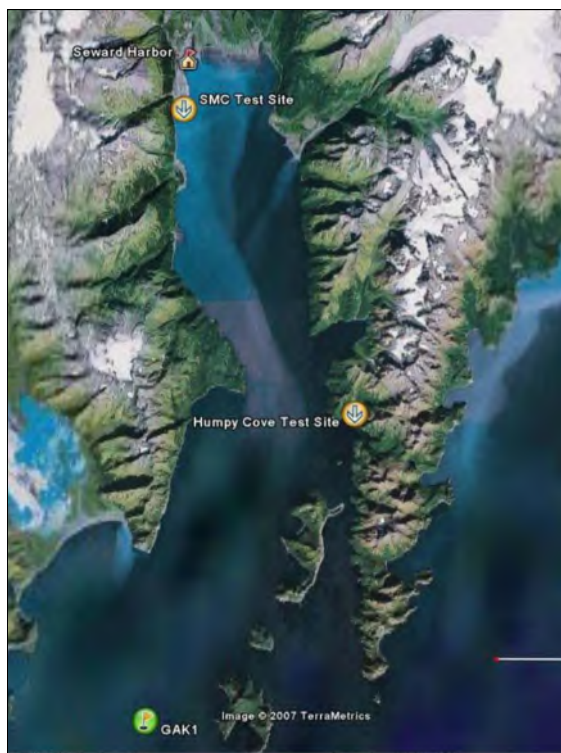
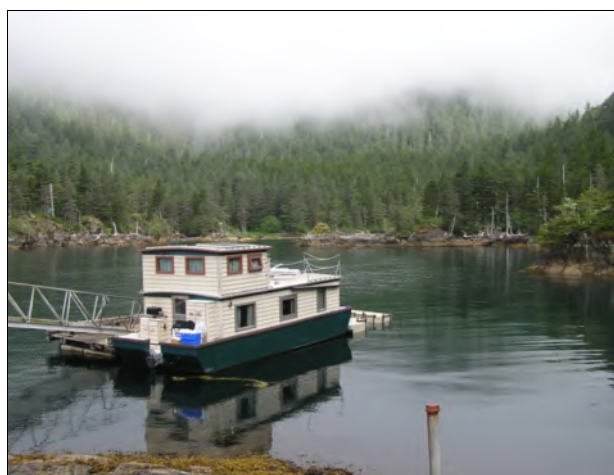
**Figure 30.** Site map and photo of the Alaska field test site located in Humpy Cove of Resurrection Bay near Seward, AK. The test instrument was deployed on a mooring frame attached to a floating dock adjacent to the house boat.

The mooring test in Resurrection Bay took place within the inlet of Humpy Cove on a floating dock attached to the end of a small fixed pier (Fig 30). The water depth of the test site was 3 m.

Deployment Site in Resurrection Bay

Floating Dock location in Humpy Cove
