## PERFORMANCE VERIFICATION STATEMENT for the YSI 6-series sonde with model 6560 Salinity Sensor

<b>TECHNOLOGY TYPE:</b>	Coupled conductivity and temperature sensors with instrument based algorithms for estimation of salinity
<b>APPLICATION:</b>	In situ estimates of salinity for coastal moored and profiled deployments
<b>PARAMETERS EVALUATED:</b>	Response linearity, accuracy, precision and reliability
<b>TYPE OF EVALUATION:</b>	Laboratory and Field Performance Verification
<b>DATE OF EVALUATION:</b>	Testing conducted from May through October 2008
<b>EVALUATION PERSONNEL:</b>	S. Gilbert, K. Gundersen, T. Johengen, T. McKissack, M. McIntyre, A. Pinchuk, H. Purcell, C. Robertson, D. Schar, G.J. Smith, M. Tamburri and D. Wells.

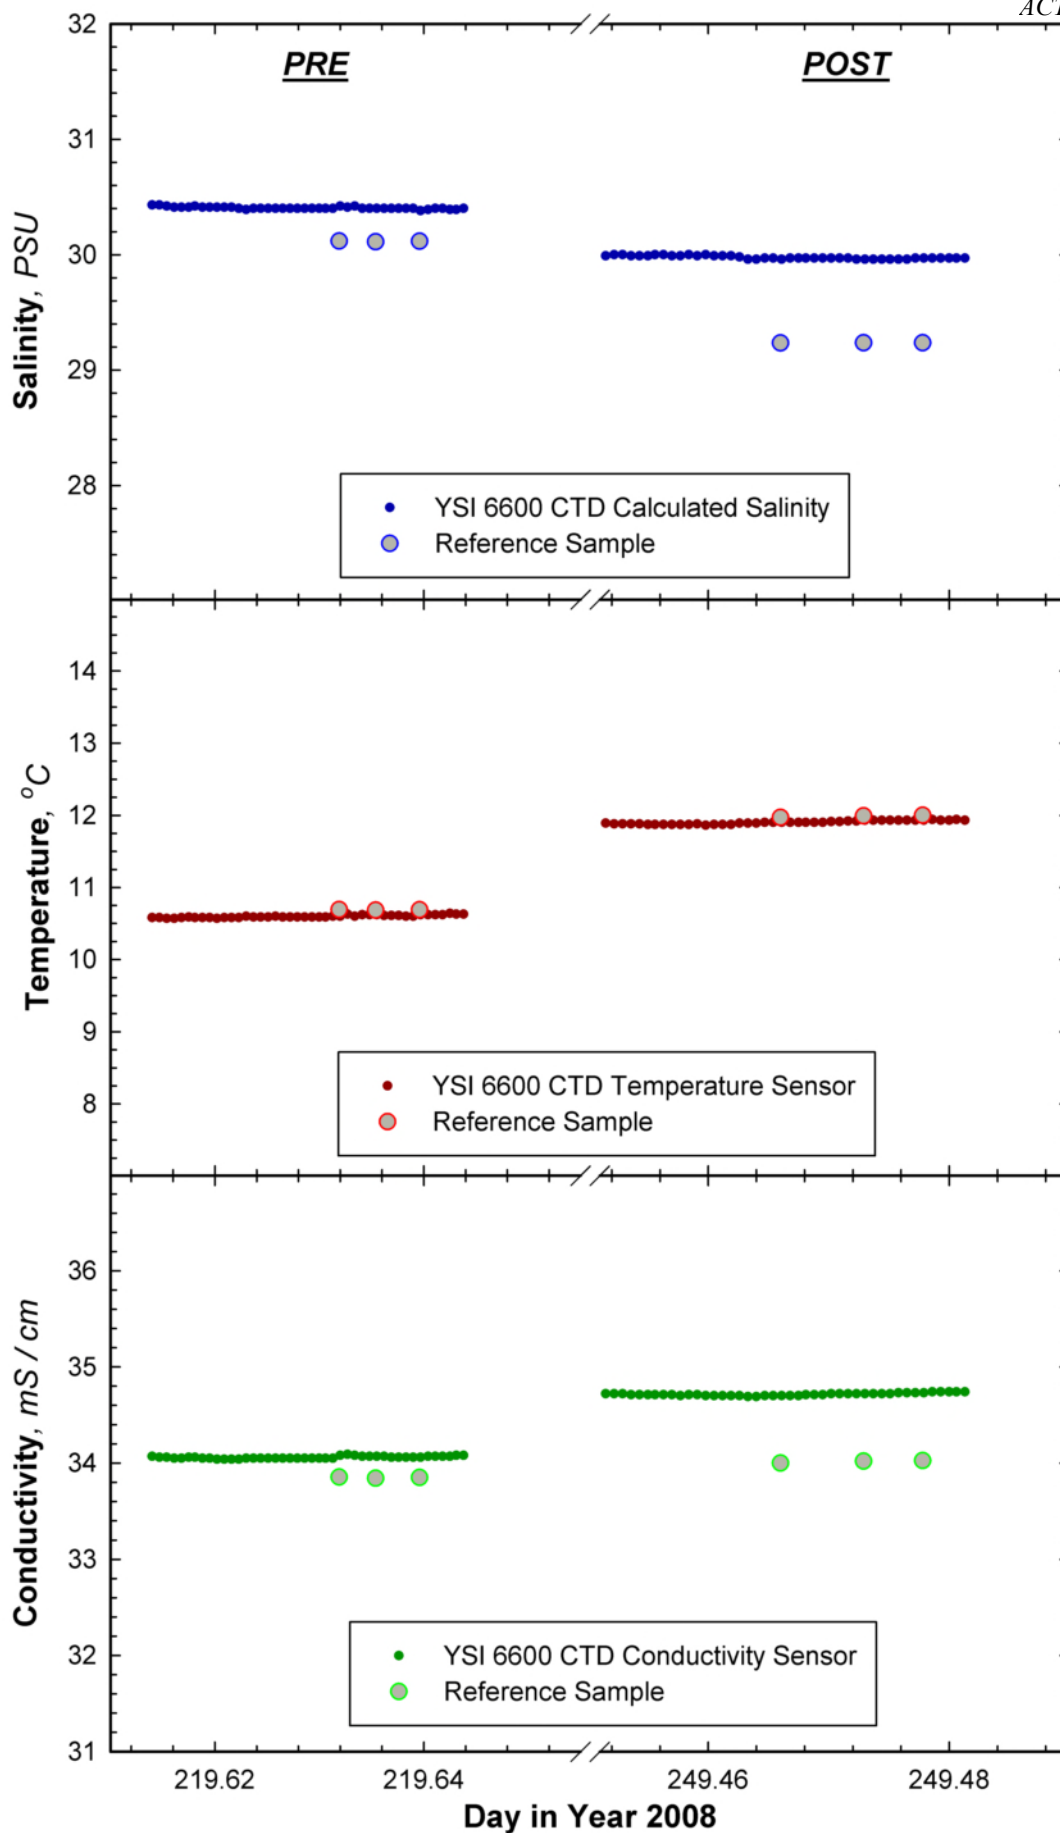
**Figure 33.** Pre- and Post-deployment reference checks in tanks of natural seawater at AK. Post-deployment tests conducted after cleaning instrument of all fouling material according to manufacturer's recommendations.

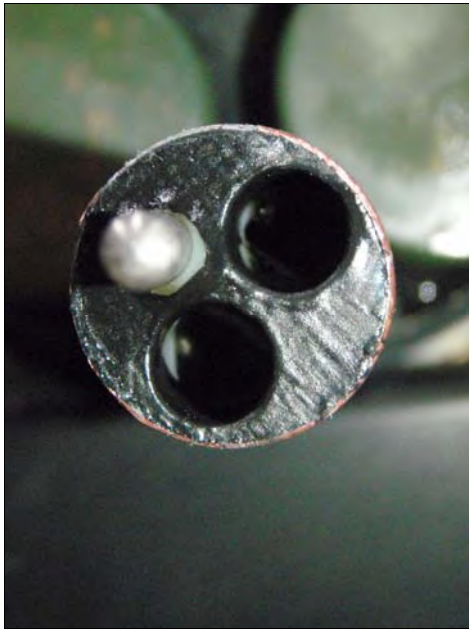
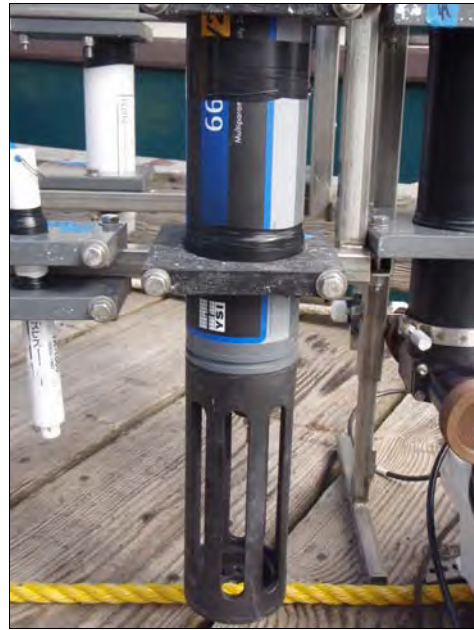
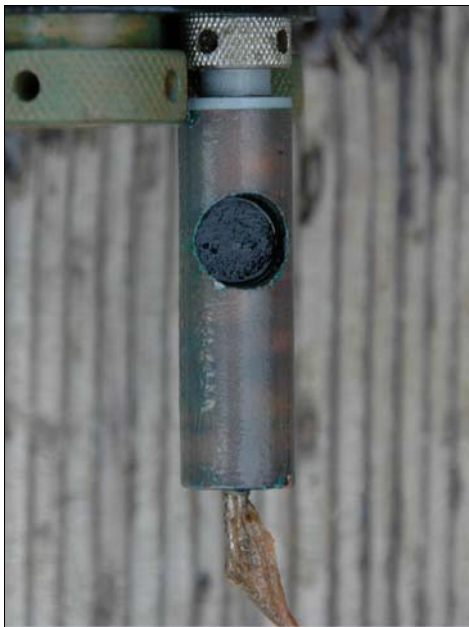
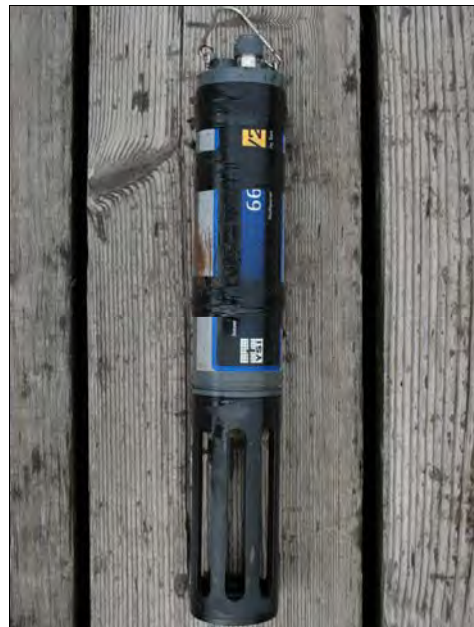
Before and after photos were taken of the instrument to examine the extent and possible impacts of bio-fouling (Fig. 34). The extent of bio-fouling at the AK test site was very small and the lowest of any of the five test sites. No hard fouling was observed.

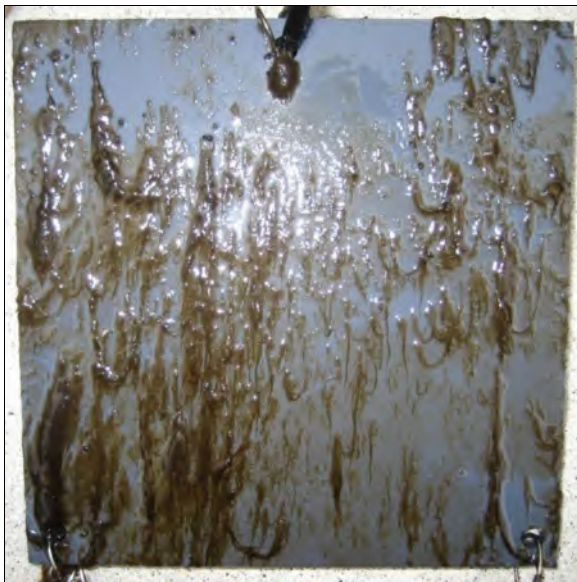
**Figure 35.** Bio-fouling plates from the Humpy Cove test site in Seward, AK.

Bio-fouling plates were retrieved and photographed once each week throughout the deployment to help define the rate and extent of biofouling within the test environment (Fig. 35). Biofouling material was mostly comprised of plant material and had a slower but consistent rate of fouling until the surface was completely covered.

AK Site Week 1

AK Site Week 2

AK Site Week 3

AK Site Week 4

Time series data of in situ measured conductivity and temperature, and derived salinity, for the AK field test were plotted against corresponding results from the laboratory analyzed reference samples and reference temperature logger (Fig. 31). Instrument measurements closely tracked sharp variations in conductivity and temperature that occurred at daily and weekly scales. The relative accuracy of the instrument measured salinity, conductivity, and temperature were depicted as numerical differences from the reference values and plotted over time (Fig. 32). In addition to an apparent initial calibration offset of around 0.3 psu, it appears that mixing events likely resulted in sharp gradients around the mooring and led to greater variance between instrument and reference sample measurements. This interpretation is supported by the lack of a specific trend in the relative accuracy over time as well as the greater variability in reference sample values obtained in QAQC sampling (see below). Results of the pre- and post-deployment exposure tests, after the instrument was cleaned to remove all biofouling, are shown in figure 33. Temperature response was nearly identical, however, a slightly greater offset was observed between the conductivity and derived salinity measure in the post-test. The amount of fouling that developed on the instrument during the deployment is shown in figure 34 and a time-series of biofouling rates on PVC tiles is shown in figure 35.

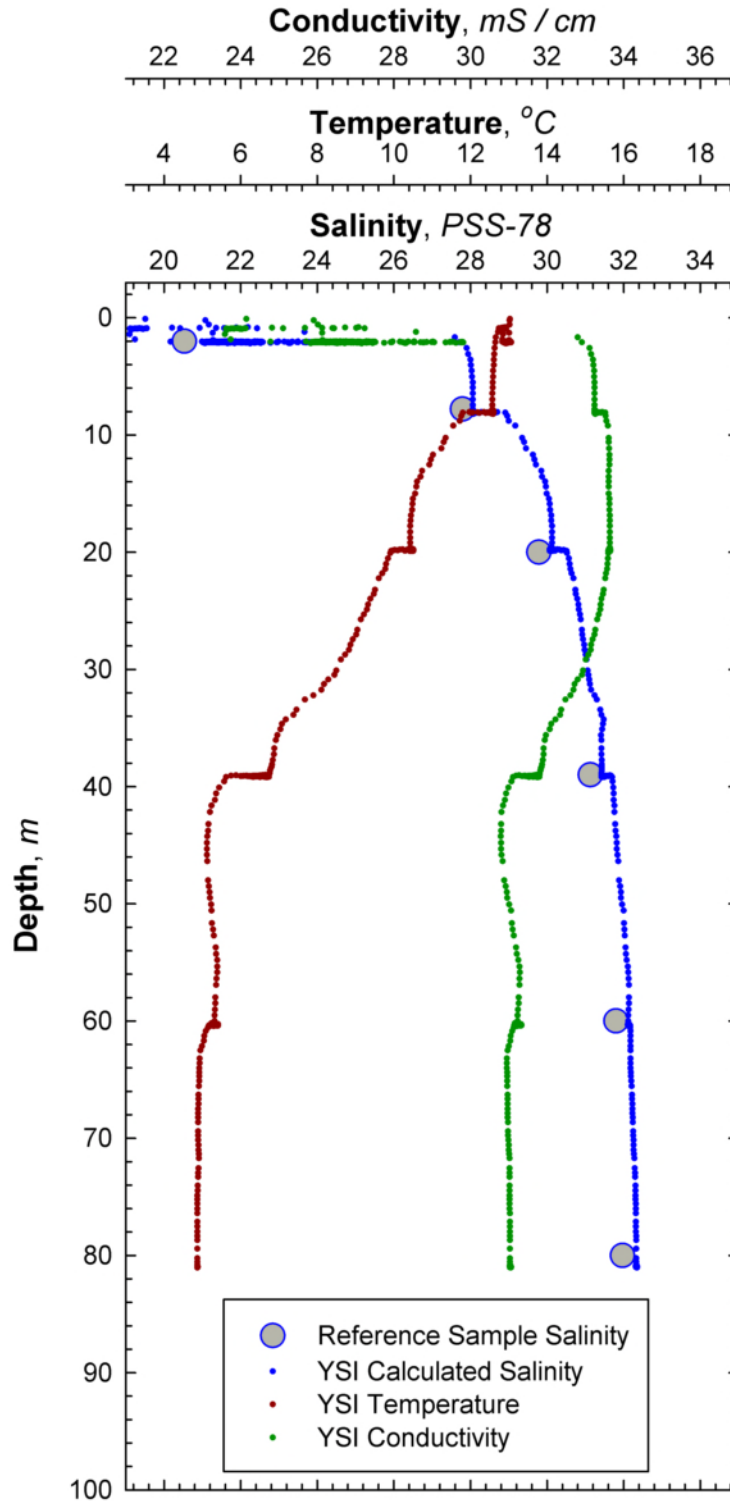
**Figure 37.** Vertical profile data from the YSI 6600 Sonde CTD deployed offshore of the Seward Marine Life Center within Resurrection Bay, AK. Sharp pycnocline at 2 m indicative of influence of glacial runoff at this site.

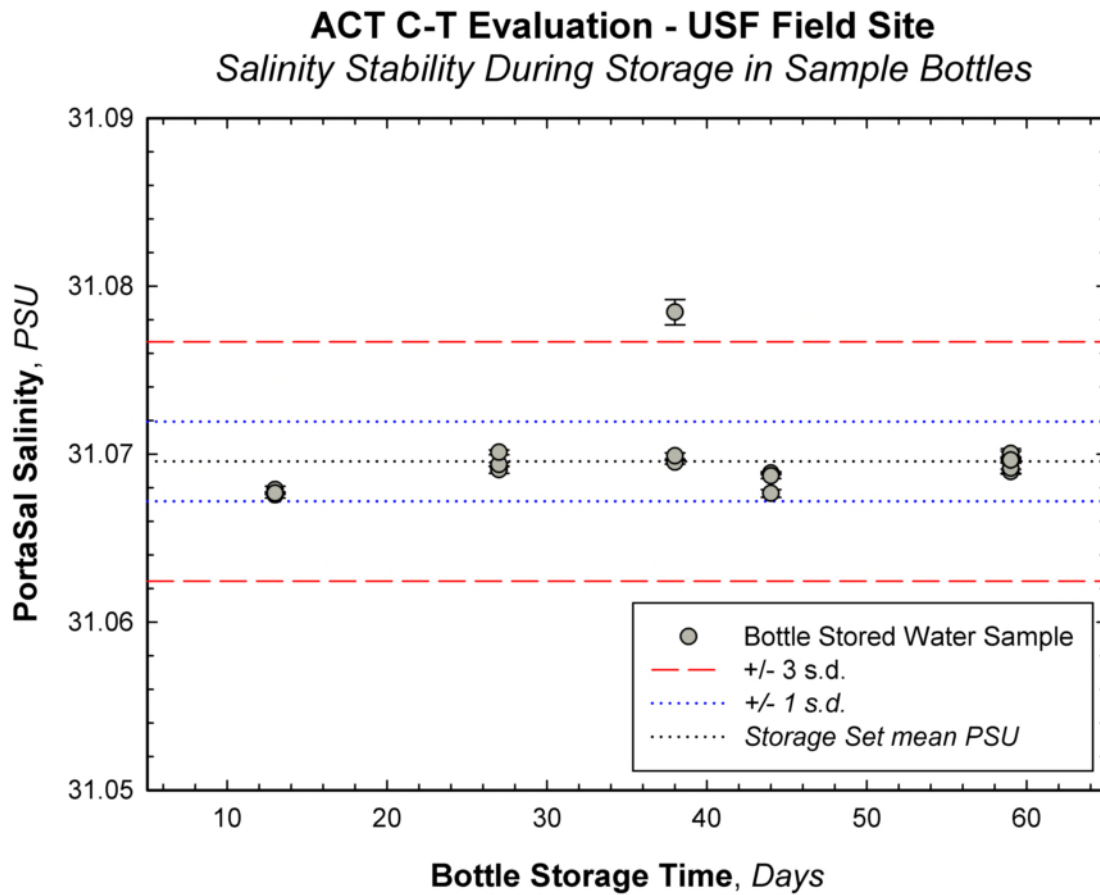
**Figure 39.** Assessment of drift in laboratory salinity measures associated with sample storage in field reference sample bottles. Sample bottles filled from single batch of test site surface water and subsets included in each sample shipment to MLML. Storage time reflects total time (days) since initial water collection.
