## PERFORMANCE VERIFICATION STATEMENT for Campbell Scientific CS547A and OBS-3A Salinity Probes

| <b>TECHNOLOGY TYPE:</b> | Coupled conductivity and temperature sensors with instrument based algorithms for estimation of salinity |
| <b>APPLICATION:</b> | In situ estimates of salinity for coastal moored and profiled deployments |
| <b>TYPE OF EVALUATION:</b> | Laboratory and Field Performance Verification |

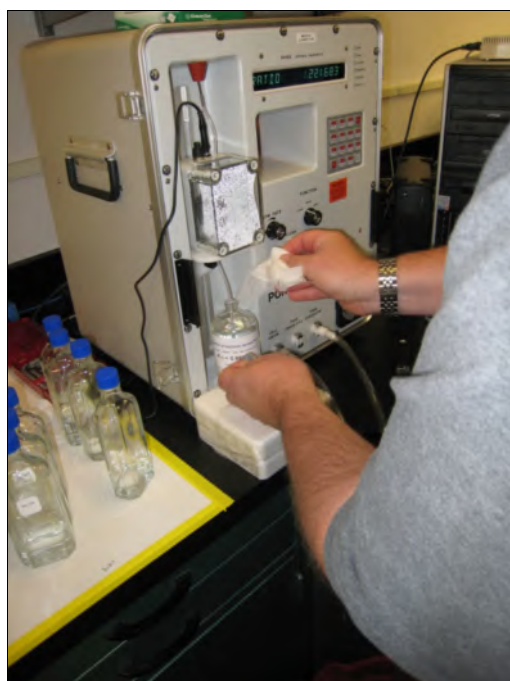
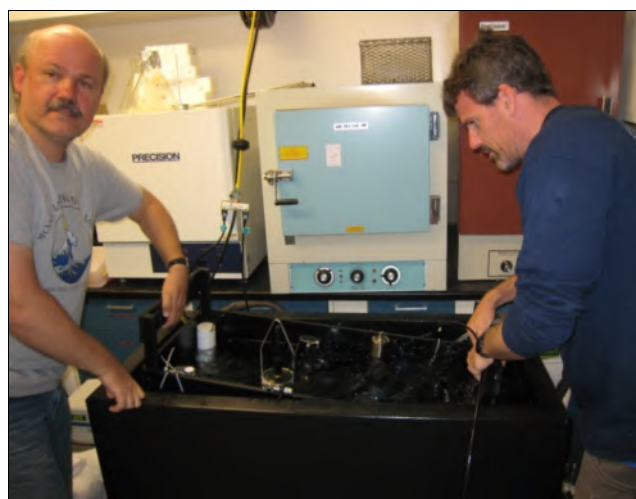
**Figure 1.** Analytical instrumentation (Portasal 8410A) used for laboratory analysis of salinity reference samples and one of the test baths and instrument racks used for the laboratory tests.

Laboratory tests focused on verifying the manufacturers' stated performance characteristics of accuracy and precision using controlled laboratory settings to obtain the highest degree of accuracy and precision for corresponding reference standards. The instrument package was tested at five different salinity levels including 35, 30, 25, 16 and 6 on the practical salinity scale (PSS-78; 60 to 6 mS/cm conductivity), each at three different temperatures including 32 °C, 16 °C and 6 °C. The instrument was pre-equilibrated to the controlled bath test conditions for 60 minutes prior to the start of reference sampling. The instrument was set to measure in situ conductivity and temperature using its own algorithms to derive a practical salinity estimate from these values at 1-minute intervals. Ten reference water samples were collected at sensor depth into sealed pre-rinsed glass salinity bottles at 3 minute intervals over 30 minutes. Each reference sample set was stored at room temperature and analyzed after 24 hours on the Portasal 8410A (Fig. 1).

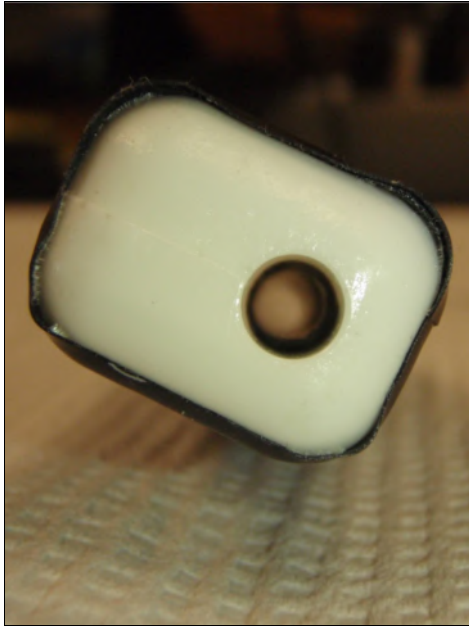
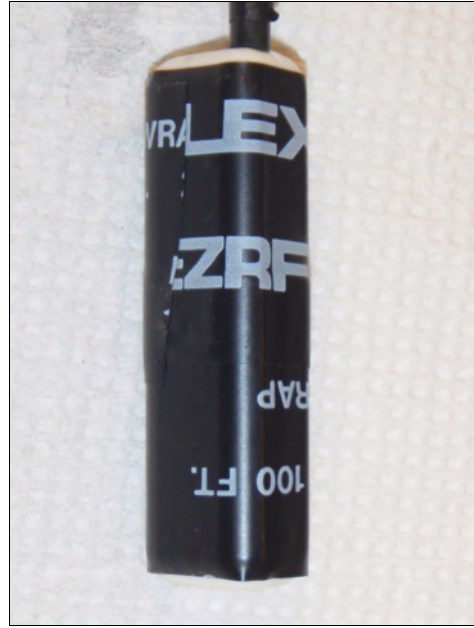
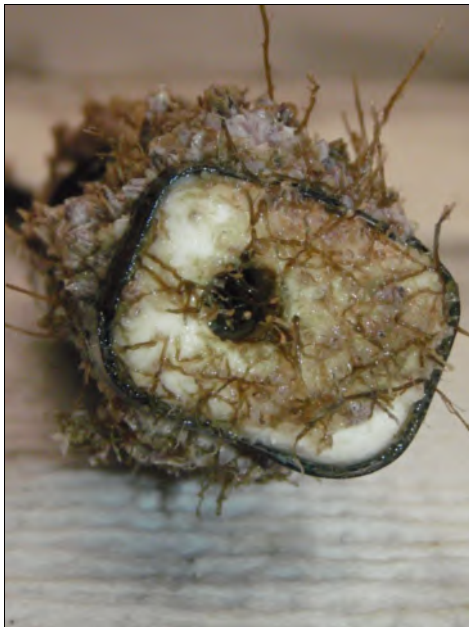
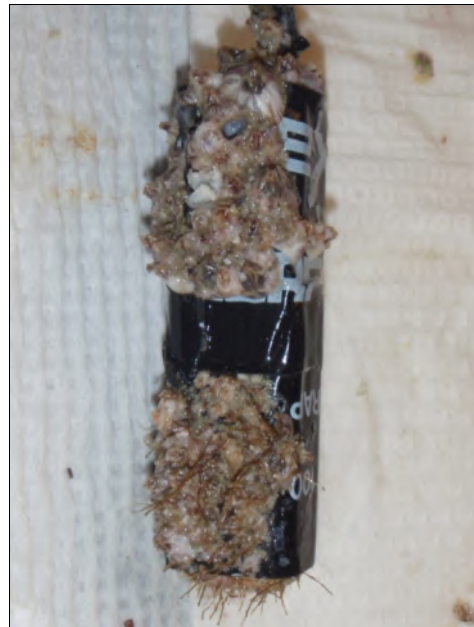
Before and after photos were taken of the instrument to examine the extent and possible impacts of bio-fouling (Fig. 10). A significant amount of hard, encrusting bio-fouling was evident across most of the instrument body by the end of the deployment, including directly within the conductivity cell.

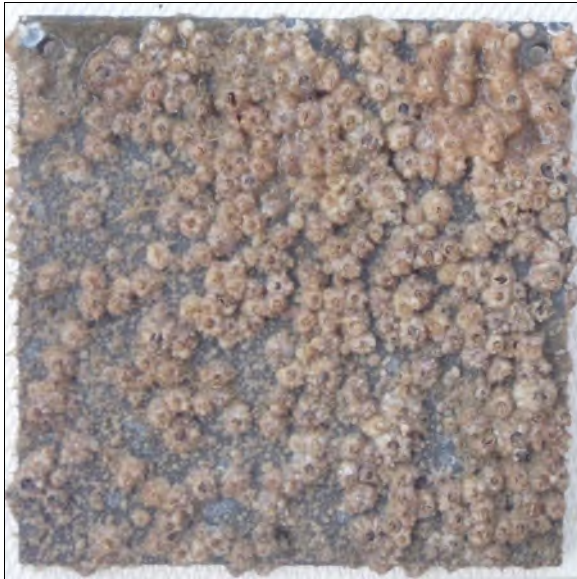
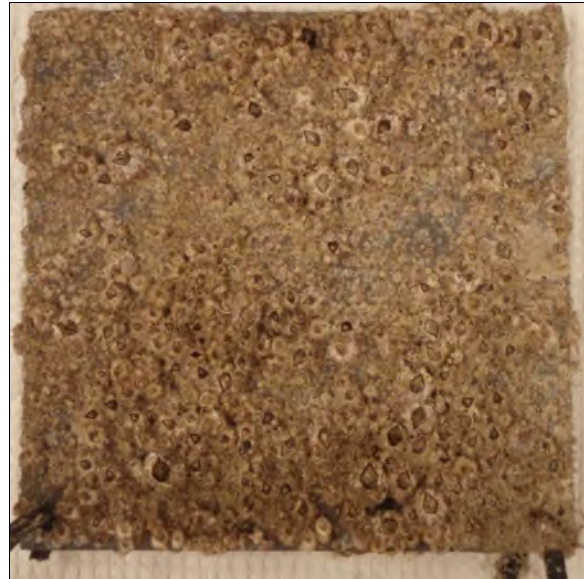
Bio-fouling plates were retrieved and photographed once each week throughout the deployment to help define the rate and extent of biofouling within the test environment (Fig. 11). By the third week of deployment there was an extensive amount of hard, encrusting biofouling at the Florida test site.

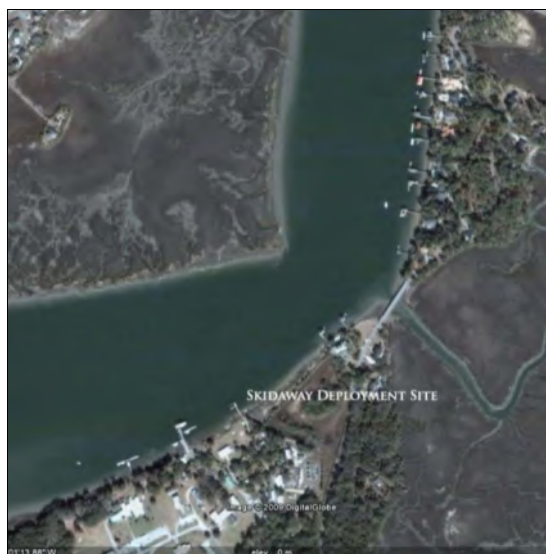
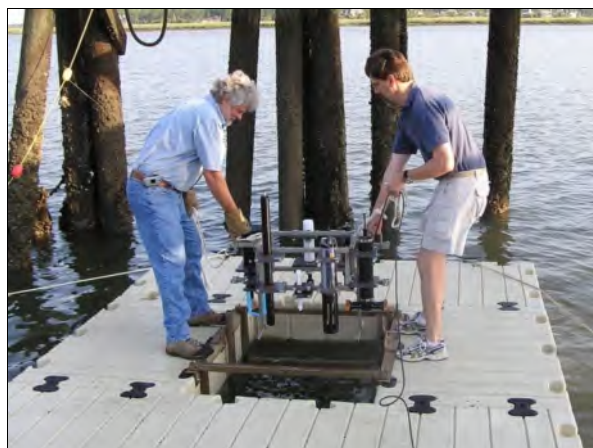
**Figure 12.** Site map and deployment arrangement for the field test conducted at Skidaway Island in Savannah, GA.

The mooring test in Georgia took place on a floating dock located on Skidaway Island on the Skidaway River (Fig. 12). The water depth of the test site was 2.3 m at minimum. The site exhibited a fairly large fluctuation in salinity, ranging from 26 – 33 PSU, and temperatures ranged from 28 – 31 °C.

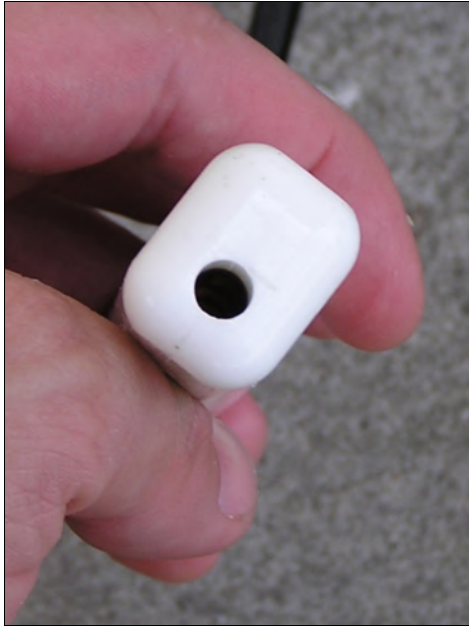
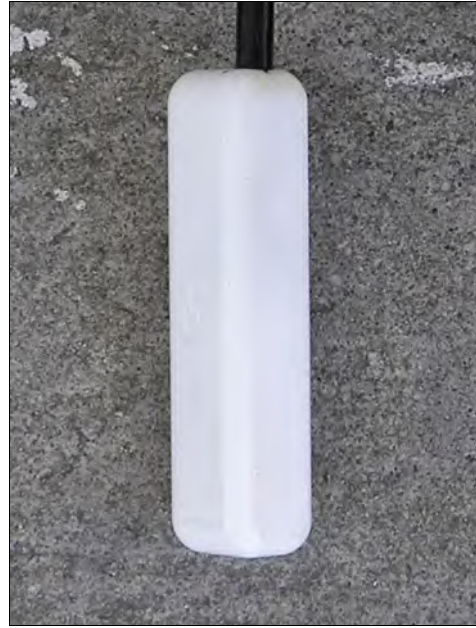
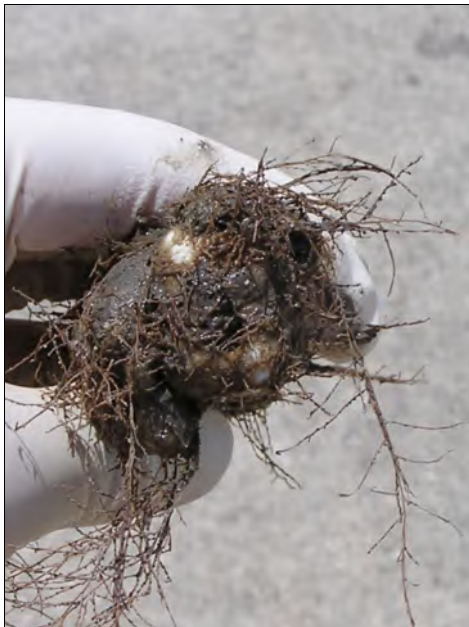
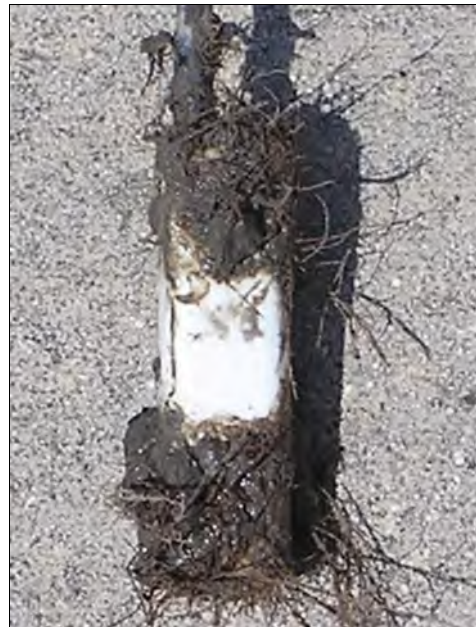
Before and after photos were taken of the instrument to examine the extent and possible impacts of bio-fouling (Fig. 16). A significant amount of soft (plant material) and hard (calcified) bio-fouling was evident across most of the instrument body by the end of the deployment including directly within the conductivity cell.

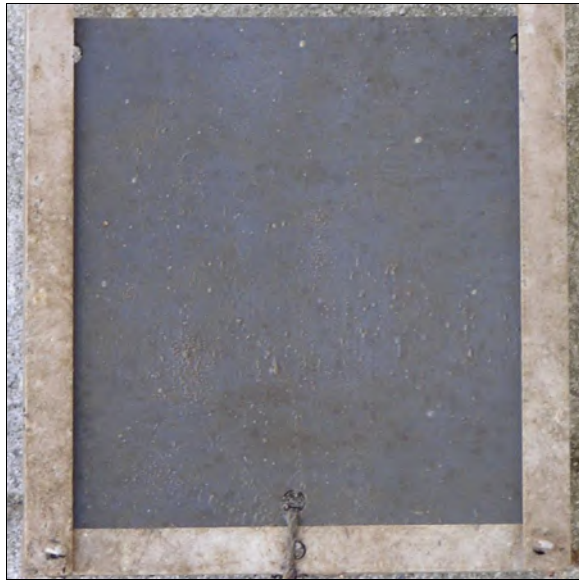
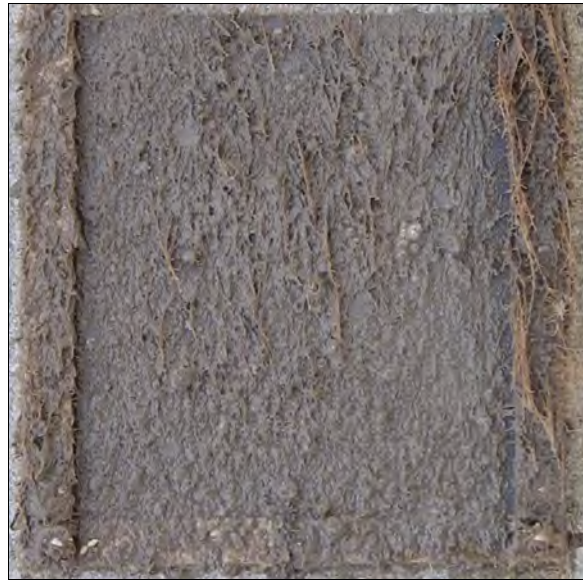
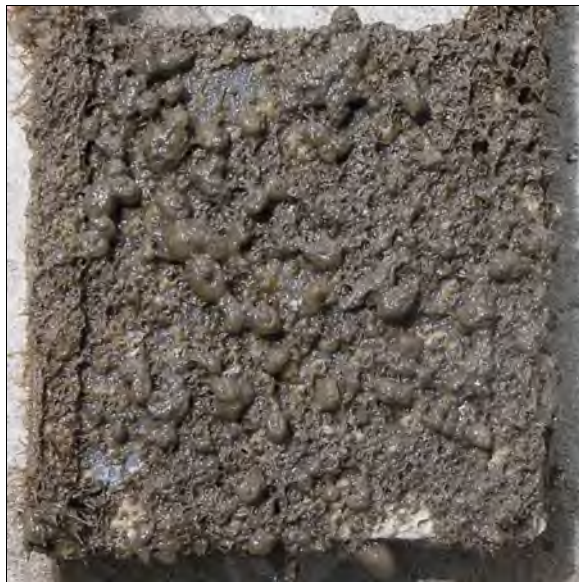
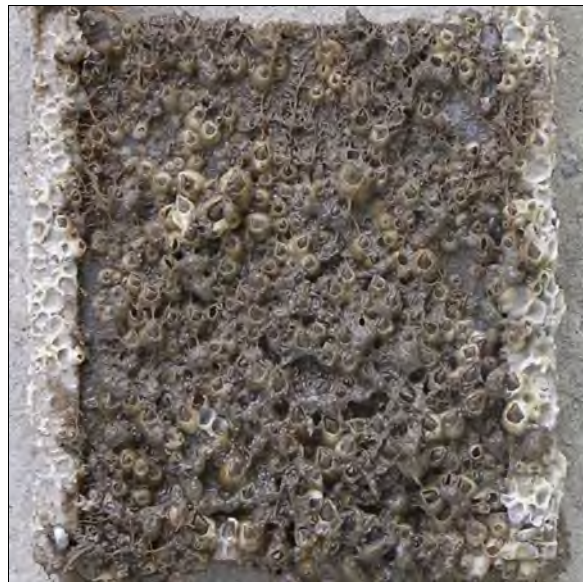
Bio-fouling plates were retrieved and photographed once each week throughout the deployment to help define the rate and extent of biofouling within the test environment (Fig. 17). Significant amounts of soft biofouling were evident by week 2 and progressed into heavy amounts of hard, encrusting biofouling at the Georgia test site.

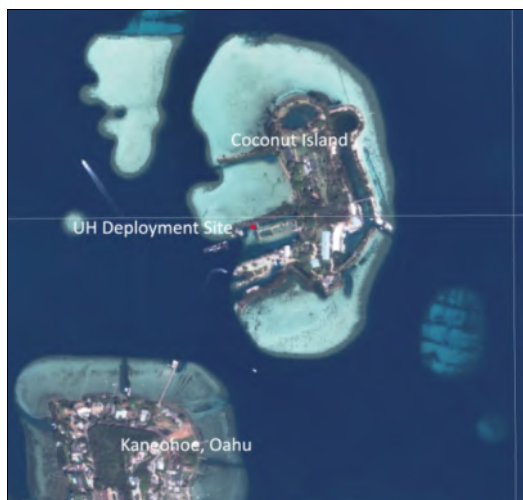
**Figure 18.** Site Photos from Field Deployment off Coconut Island, Kaneohe Bay, HI.

The mooring test in Kaneohe Bay took place on the fringing reef flat surrounding Coconut Island. The instruments were placed on a standing rack (Fig. 18) in a water depth of 3 meters with tidal variations typically less than 0.5 m at this site. During the deployment test, salinity values ranged from 33 to 35.5 and water temperatures from 26.1 to 29.6 °C.

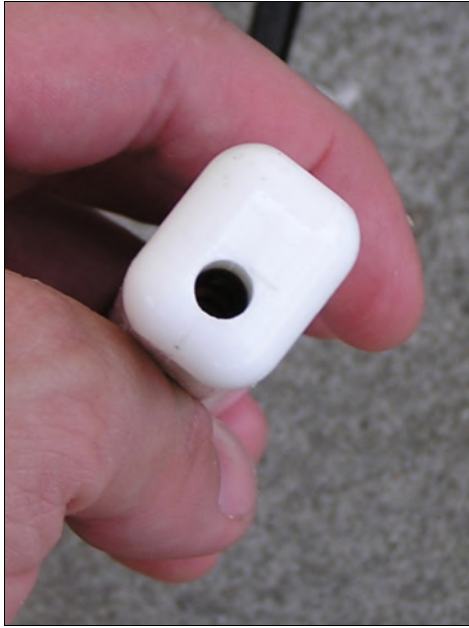
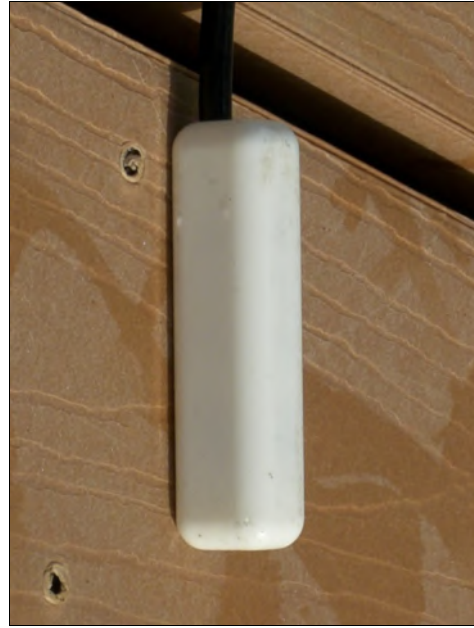
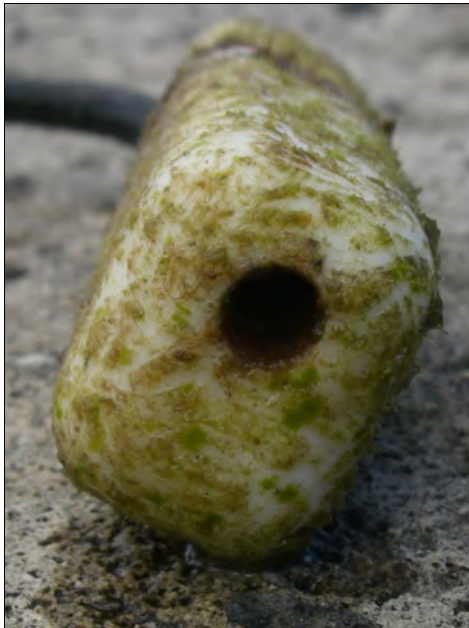
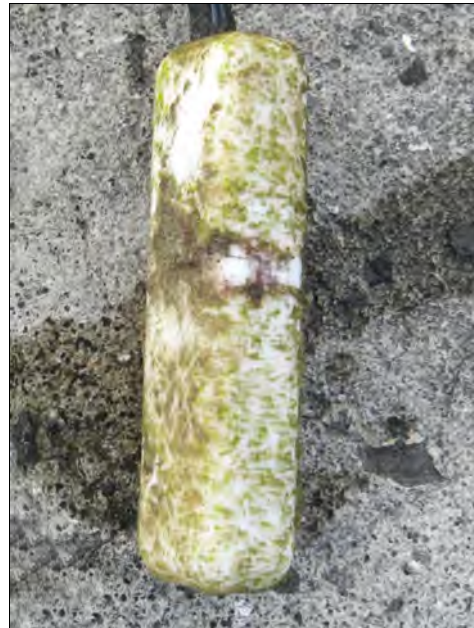
Before and after photos were taken of the instrument to examine the extent and possible impacts of bio-fouling (Fig. 22). The extent of bio-fouling was significantly less at this test site relative to FL or GA despite the longer deployment period and was mostly comprised of plant material and worm cases.

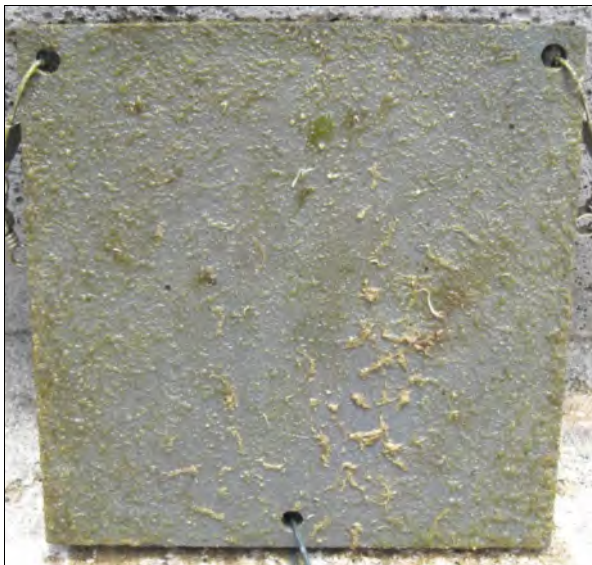
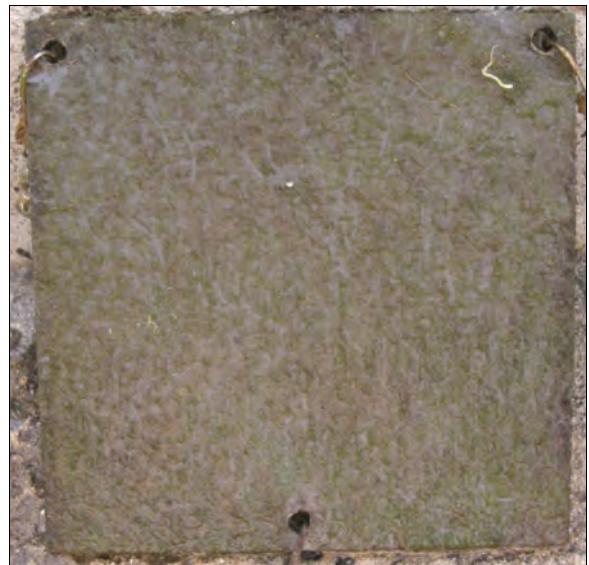
Bio-fouling plates were retrieved and photographed once each week throughout the deployment to help define the rate and extent of biofouling within the test environment. A subset of the plate photographs covering weeks 1, 2, 4, and 8 are shown in Figure 23. The extent of bio-fouling was significantly less at this test site relative to FL or GA despite the longer deployment period and was mostly comprised of plant material and worm cases.

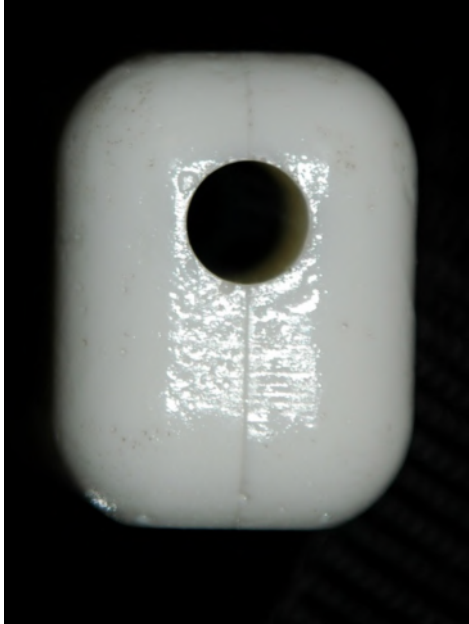
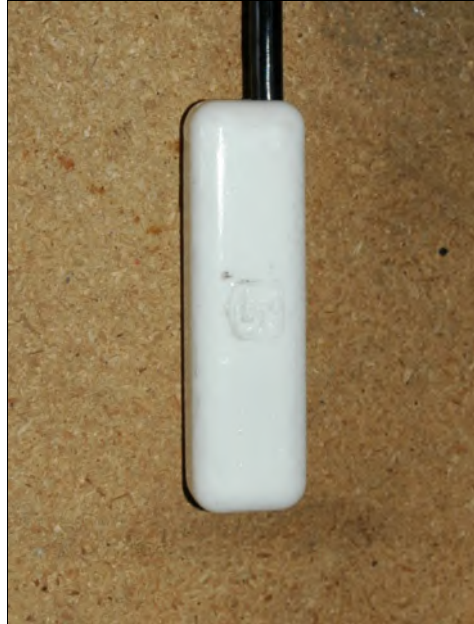
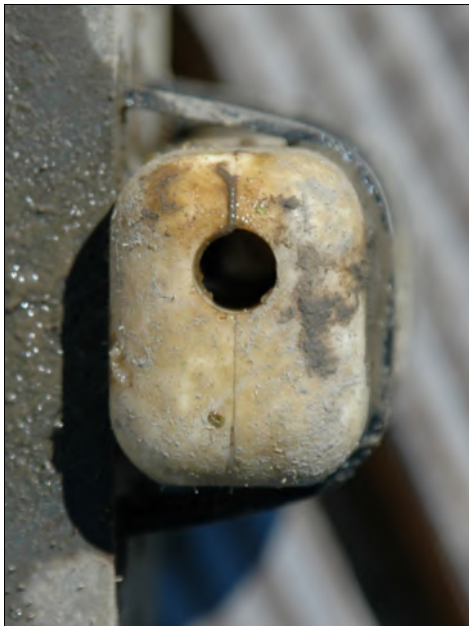
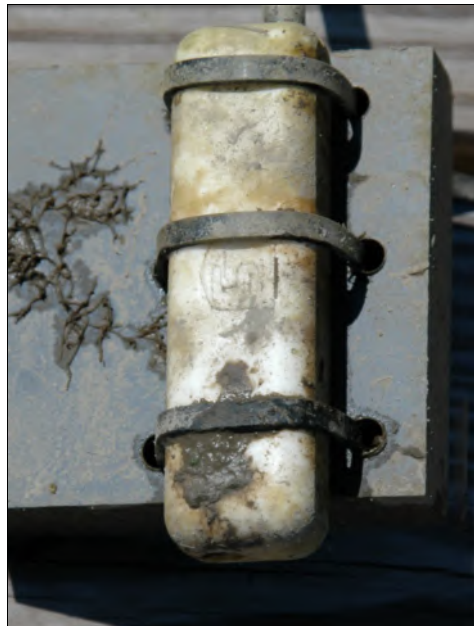
**Figure 28.** CS547A instrument photos from the Clinton River, MI test site before and after deployment

Before and after photos were taken of the instrument to examine the extent and possible impacts of bio-fouling (Fig. 28). The extent of bio-fouling was quite low at the MI test site and consisted of only soft plant material.

Time series data of in situ measured conductivity and temperature, and derived salinity, for the MI field test were plotted against corresponding results from the laboratory analyzed reference samples and reference temperature logger (Fig. 25). The CS547A measurements closely matched reference sample measurements throughout the entire 29 day deployment and captured several sharp rises and falls in both conductivity and temperature at this site. The average measurement error in salinity, conductivity and temperature was -0.0148, -0.0285, and 0.0082, respectively over the deployment (Fig. 26). The offset in the instrument salinity, conductivity, and temperature measurements was nearly identical between the pre- and post-deployment exposure test (Fig. 27). In general there was very little fouling impact at this site. The amount of fouling that developed on the instrument during the deployment is shown in figure 28 and a time-series of biofouling rates on PVC tiles is shown in figure 29.

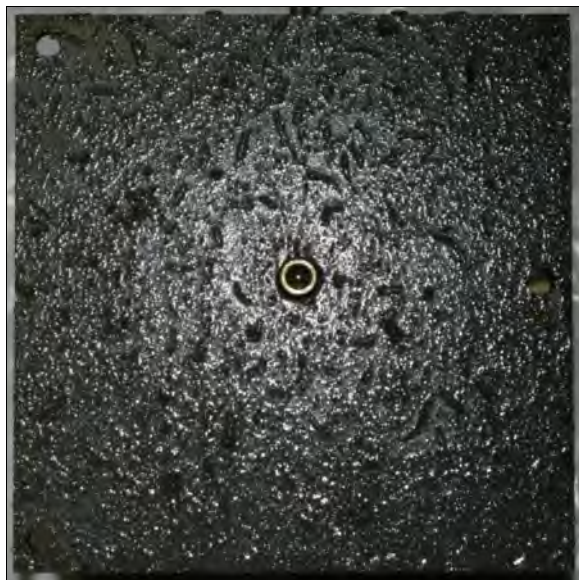
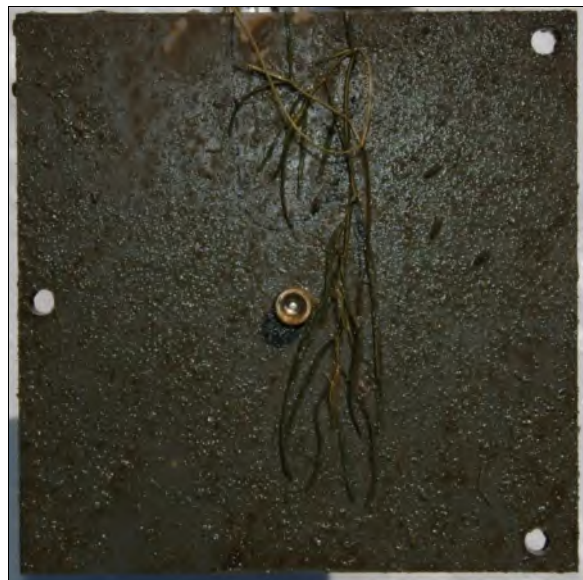
Bio-fouling plates were retrieved and photographed once each week throughout the deployment to help define the rate and extent of biofouling within the test environment (Fig. 29). Biofouling material was mostly comprised of plant material and developed rather quickly but did not appear to accumulate significantly once the original surface was covered.

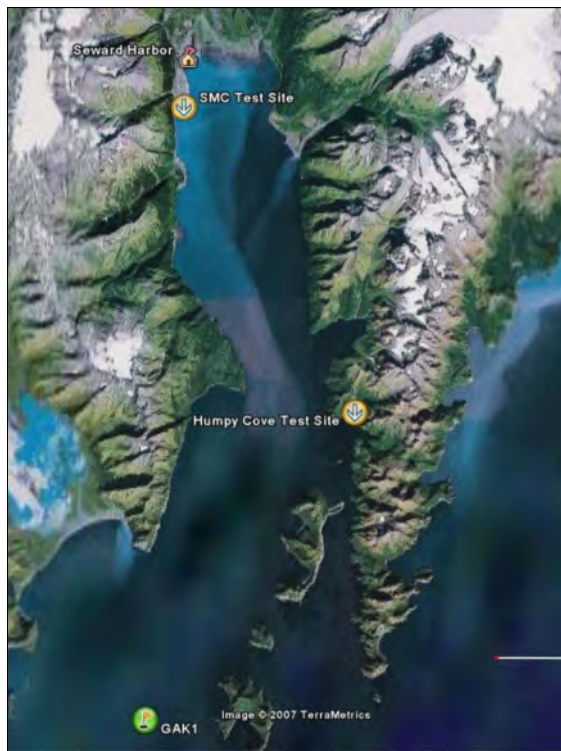
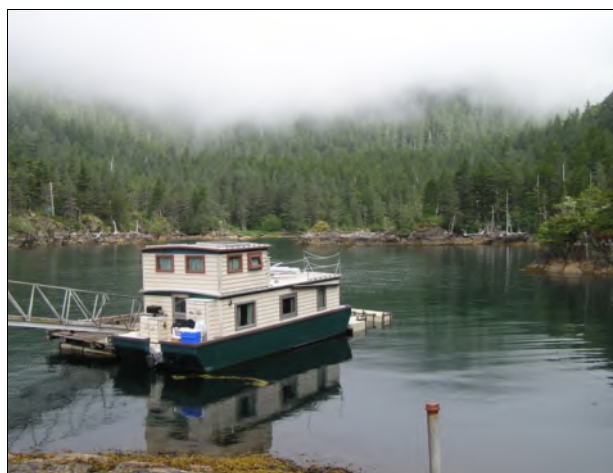
**Figure 30.** Site map and photo of the Alaska field test site located in Humpy Cove of Resurrection Bay near Seward, AK. The test instrument was deployed on a mooring frame attached to a floating dock.

The mooring test in Resurrection Bay took place within the inlet of Humpy Cove on a floating dock attached to the end of a small fixed pier (Fig 30). The water depth of the test site was 3 m.

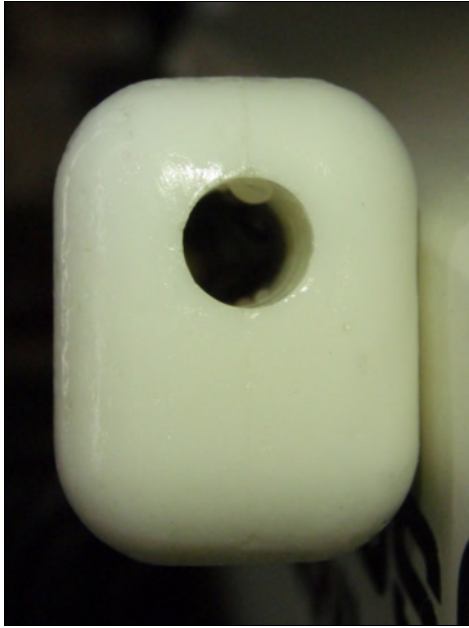
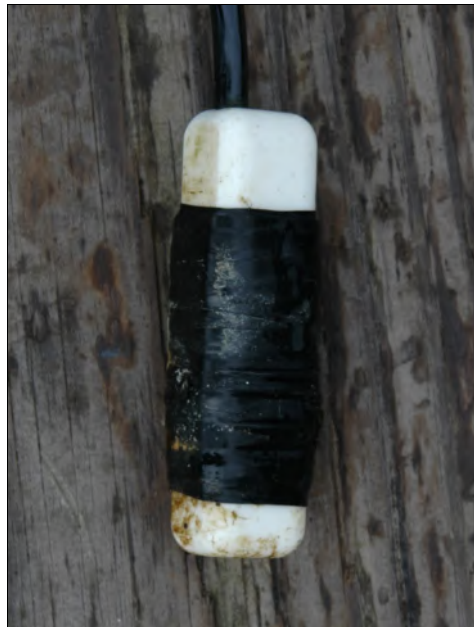
Before and after photos were taken of the instrument to examine the extent and possible impacts of bio-fouling (Fig. 34). The extent of bio-fouling at the AK test site was very small and the lowest of any of the five test sites. No hard fouling was observed.

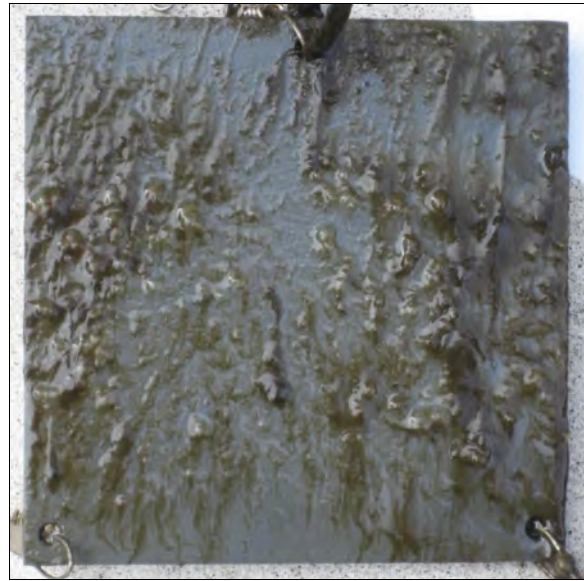
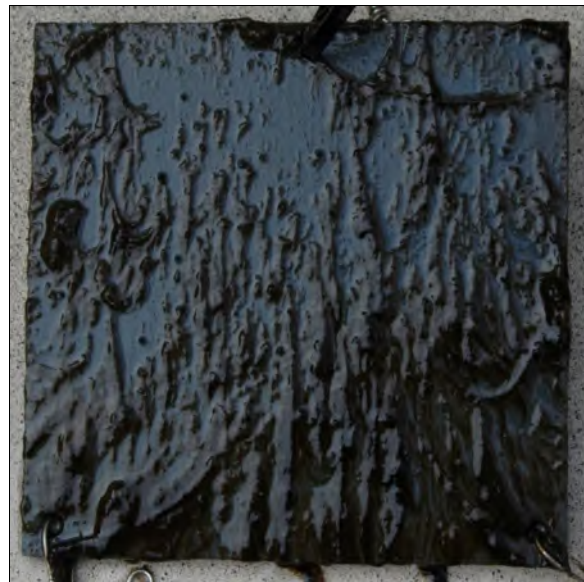
**Figure 35.** Bio-fouling plates from the Humpy Cove test site in Seward, AK.

Bio-fouling plates were retrieved and photographed once each week throughout the deployment to help define the rate and extent of biofouling within the test environment (Fig. 35). Biofouling material was mostly comprised of plant material and had a slower but consistent rate of fouling until the surface was completely covered.

Time series data of in situ measured conductivity and temperature, and derived salinity, for the AK field test were plotted against corresponding results from the laboratory analyzed reference samples and reference temperature logger (Fig. 31). The relative accuracy of the instrument measured salinity, conductivity, and temperature were depicted as numerical differences from the reference values and plotted over time (Fig. 32). The measurement error in salinity ranged from 0.924 to 4.69 with a mean of 3.69 psu. For this deployment the response was more consistent throughout the deployment but ended higher over the last 10 days. The mean measurement error of the temperature sensor over the deployment period was  $-0.0792^{\circ}\text{C}$ . Results of the pre- and post-deployment exposure tests, after the instrument was cleaned to remove all biofouling, are shown in figure 33. Temperature response was nearly identical between pre- and post-exposure tests, however, offsets in conductivity and derived salinity measure increased significantly for the post-test. The amount of fouling that developed on the instrument during the deployment is shown in figure 34 and a time-series of biofouling rates on PVC tiles is shown in figure 35.
