## PERFORMANCE VERIFICATION STATEMENT for the RBR XR-420 and XR-620 CTD Salinity Sensors

<b>TECHNOLOGY TYPE:</b>	Coupled conductivity and temperature sensors with instrument based algorithms for estimation of salinity
<b>APPLICATION:</b>	In situ estimates of salinity for coastal moored and profiled deployments
<b>PARAMETERS EVALUATED:</b>	Response linearity, accuracy, precision and reliability
<b>TYPE OF EVALUATION:</b>	Laboratory and Field Performance Verification
<b>DATE OF EVALUATION:</b>	Testing conducted from May through October 2008
<b>EVALUATION PERSONNEL:</b>	S. Gilbert, K. Gundersen, T. Johengen, T. McKissack, M. McIntyre, A. Pinchuk, H. Purcell, C. Robertson, D. Schar, G.J. Smith, M. Tamburri and D. Wells.

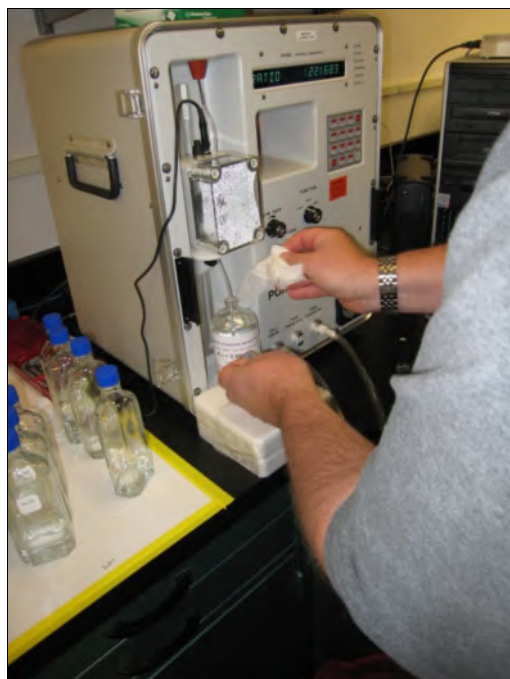
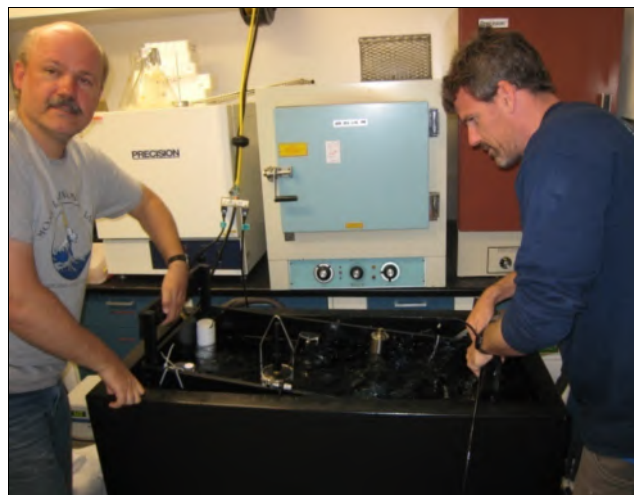
**Figure 1.** Analytical instrumentation (Portasal 8410A) used for laboratory analysis of salinity reference samples and one of the test baths and instrument racks used for the laboratory tests.

Laboratory tests focused on verifying the manufacturers' stated performance characteristics of accuracy and precision using controlled laboratory settings to obtain the highest degree of accuracy and precision for corresponding reference standards. The instrument package was tested at five different salinity levels including 35, 30, 25, 16 and 6 on the practical salinity scale (PSS-78; 60 to 6 mS/cm conductivity), each at three different temperatures including 32 °C, 16 °C and 6 °C. The instrument was pre-equilibrated to the controlled bath test conditions for 60 minutes prior to the start of reference sampling. The instrument was set to measure in situ conductivity and temperature using its own algorithms to derive a practical salinity estimate from these values at 1-minute intervals. Ten reference water samples were collected at sensor depth into sealed pre-rinsed glass salinity bottles at 3 minute intervals over 30 minutes. Each reference sample set was stored at room temperature and analyzed after 24 hours on the Portasal 8410A (Fig. 1).

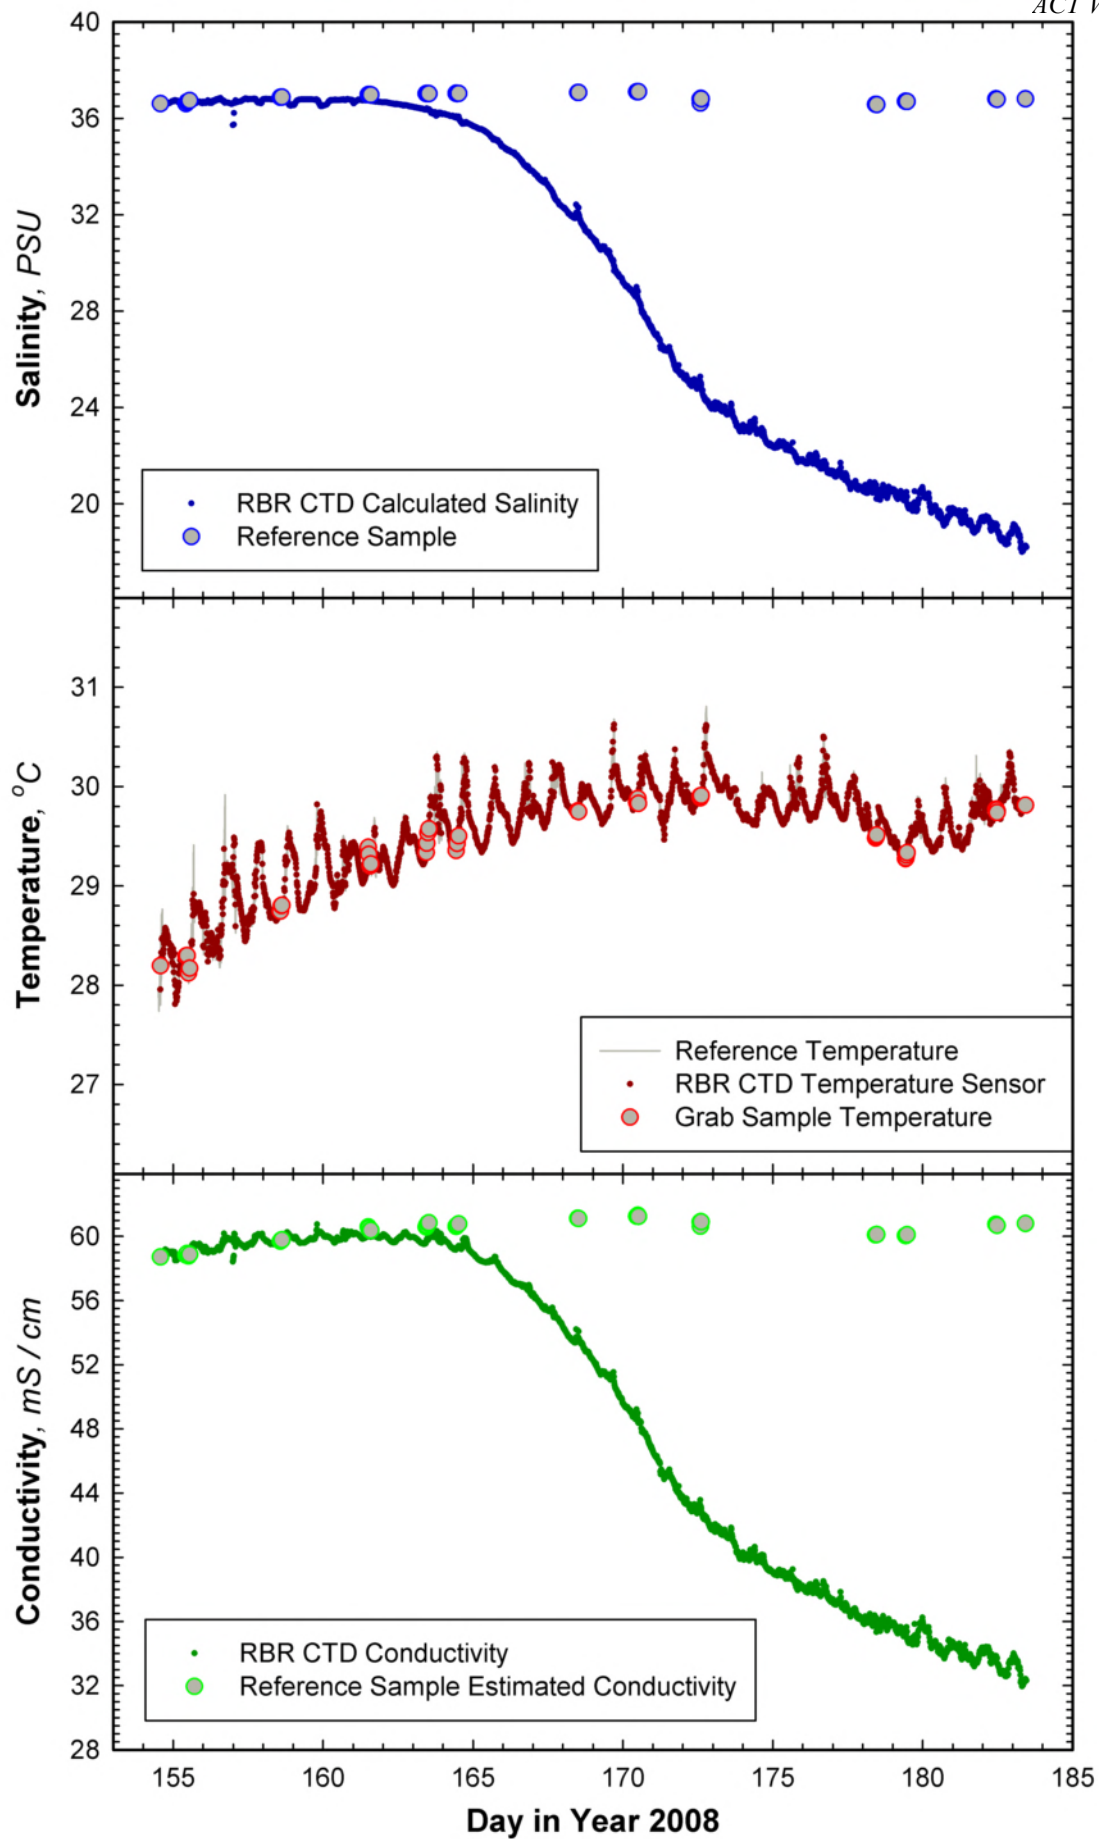
**Figure 7.** Time series of instrument measurements and corresponding reference samples acquired during USF field deployment.

Time series data of in situ measured conductivity and temperature, and derived salinity, for the FL field test were plotted against corresponding results from the laboratory analyzed reference samples and reference temperature logger (Fig. 7). Instrument measurements appeared to be impacted by fouling after only a few days when absolute differences in measured salinity went from an initial value of 0.036 to -0.224 on day 6 and then continued to decrease sharply (Fig. 8). The offset in measured salinity was clearly related to performance of the conductivity cell, and the temperature sensor response was quite consistent throughout the deployment despite the presence of heavy biofouling with a mean offset of 0.0048 °C. A test to confirm that changes in instrument performance were due to biofouling and not electronic drift was completed by comparing measurement accuracy in pre- and post- exposures in well mixed reference sampled tanks, after the instrument was cleaned to remove all biofouling (Fig 9). The agreement between instrument and reference sample values was nearly identical between the two suggesting biofouling was the direct cause of the decreased performance. The amount of fouling that developed on the instrument during the deployment is shown in figure 10 and a time-series showing the rate of biofouling captured on PVC tiles is shown in figure 11.

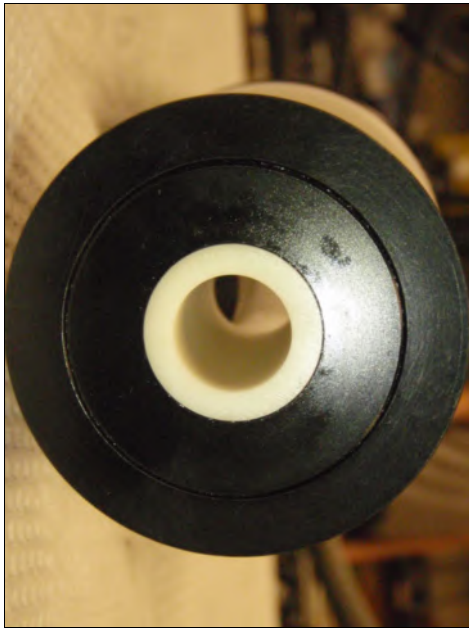
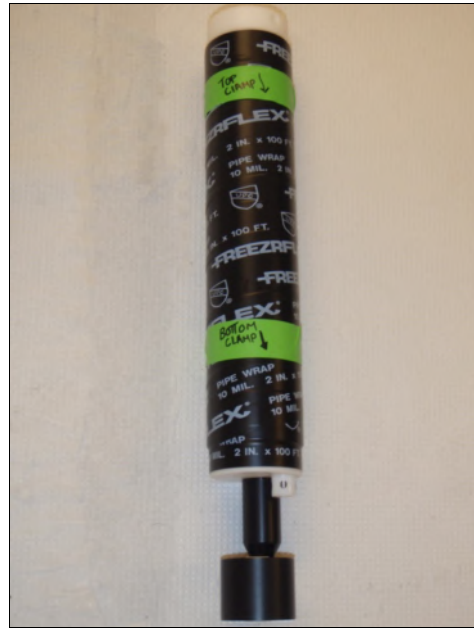
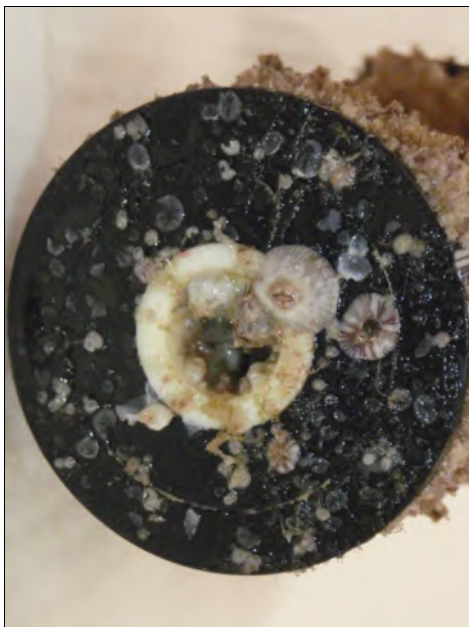
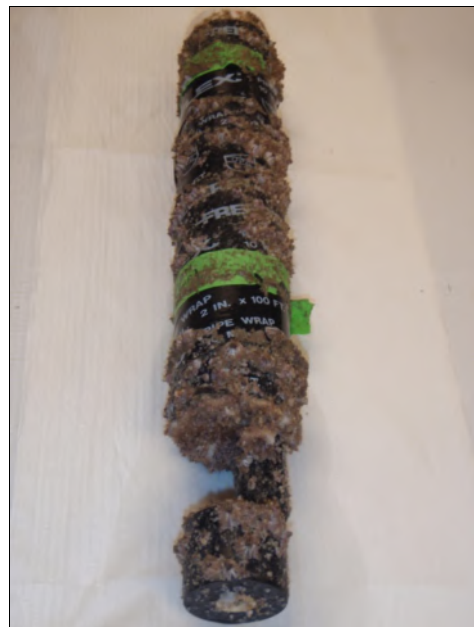
Before and after photos were taken of the instrument to examine the extent and possible impacts of bio-fouling (Fig. 10). A significant amount of hard, encrusting bio-fouling was evident across most of the instrument body by the end of the deployment despite the application of an anti-fouling wax, and directly within the conductivity cell where no wax was applied.

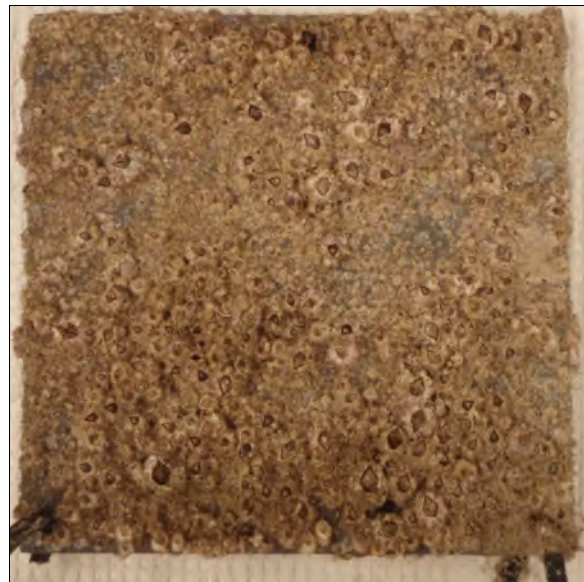
Bio-fouling plates were retrieved and photographed once each week throughout the deployment to help define the rate and extent of biofouling within the test environment (Fig. 11). By the third week of deployment there was an extensive amount of hard, encrusting biofouling at the Florida test site.

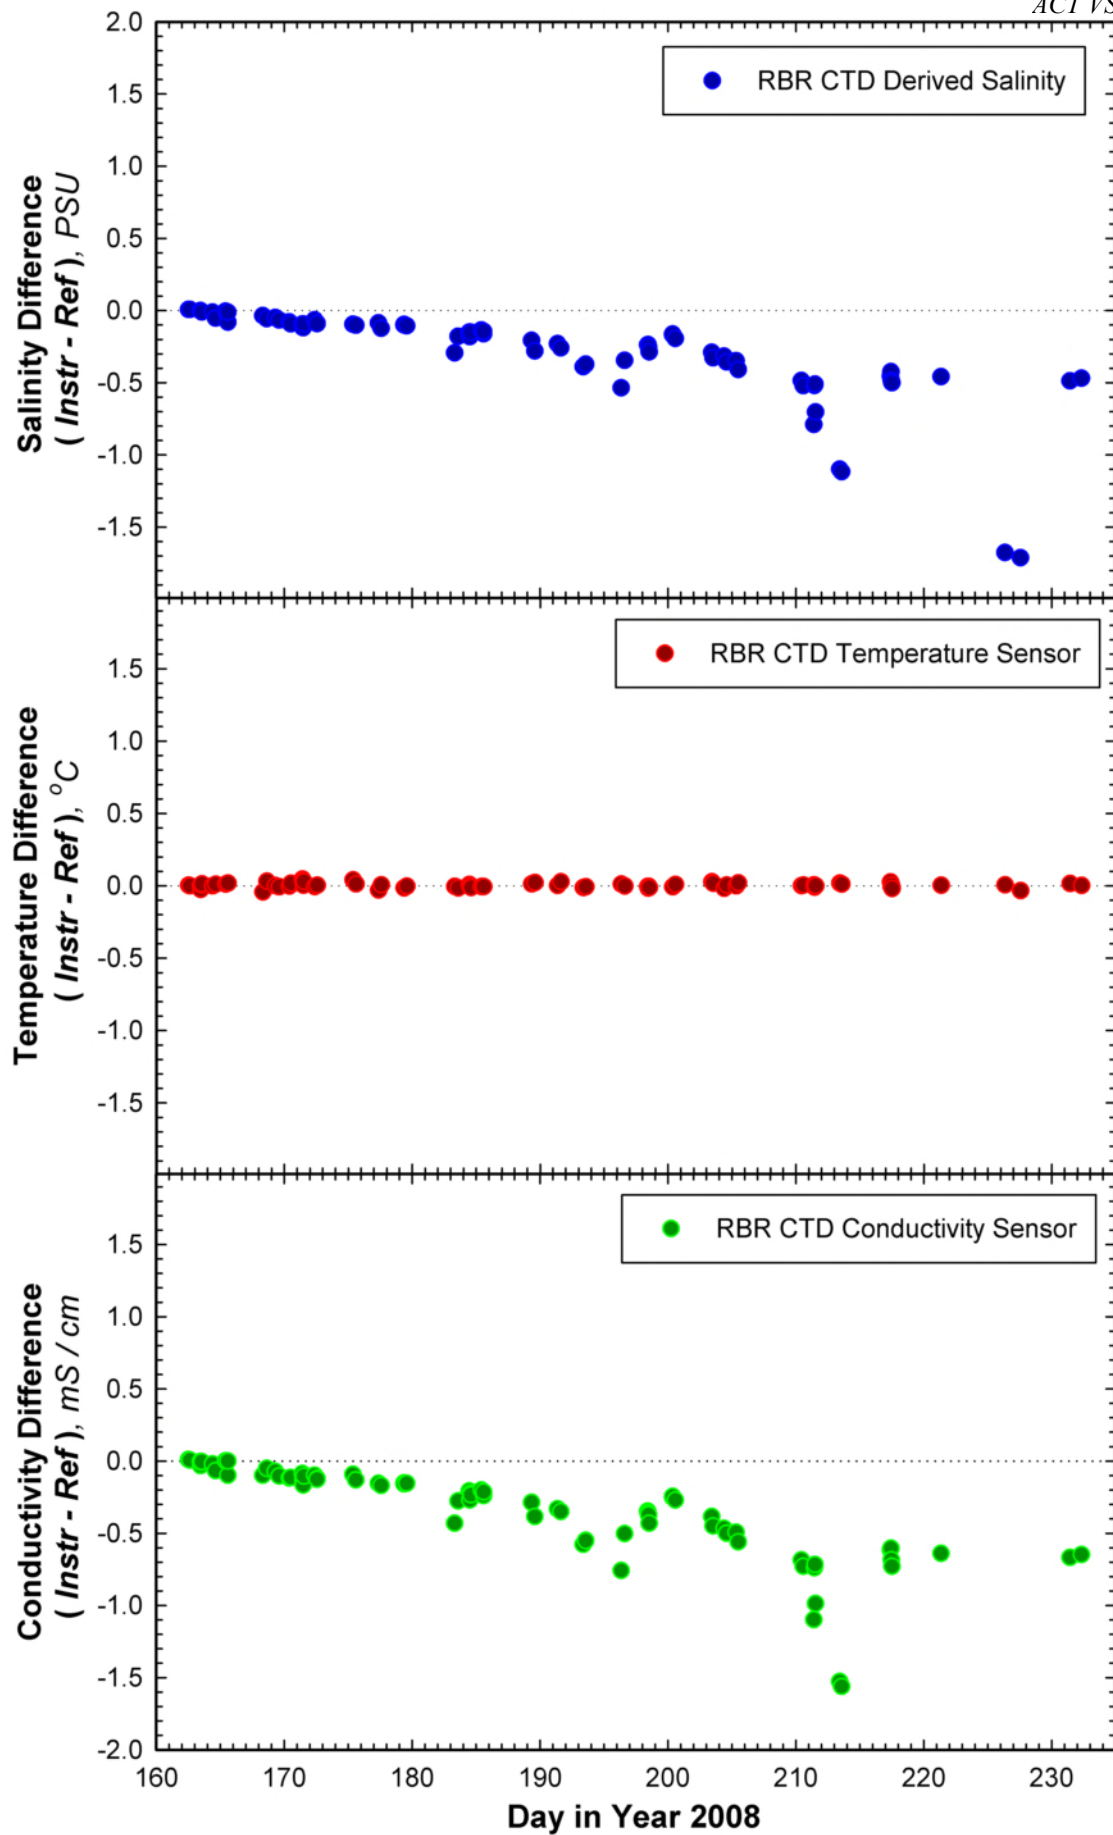
**Figure 20.** Assessment of relative accuracy of instrument time series measurements during the HI field deployment.

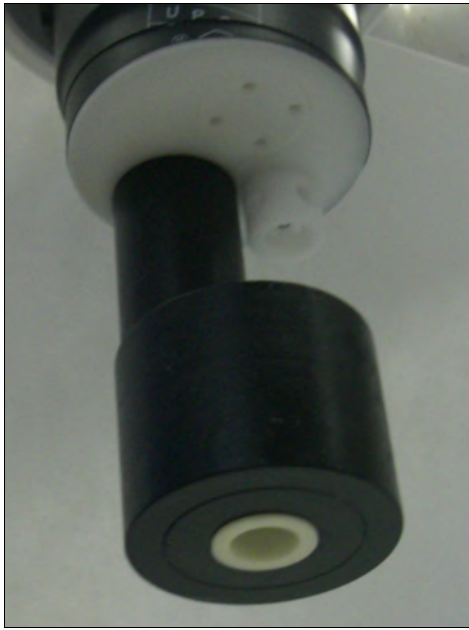
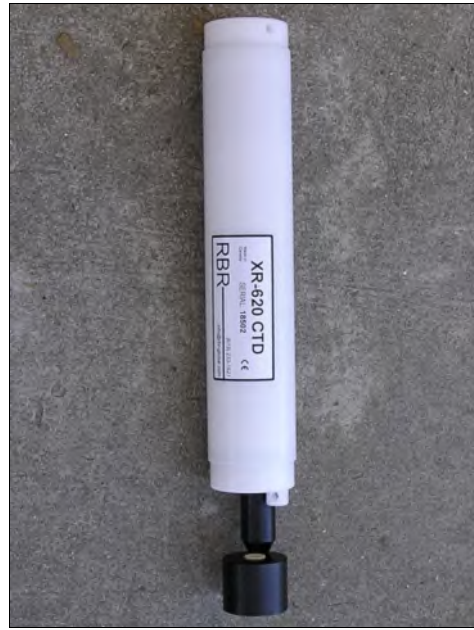
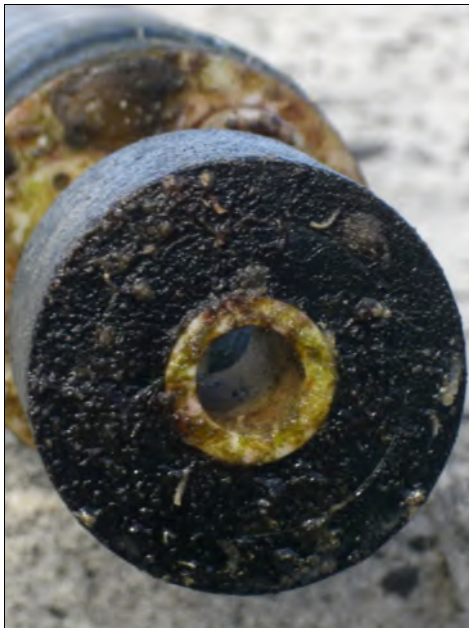
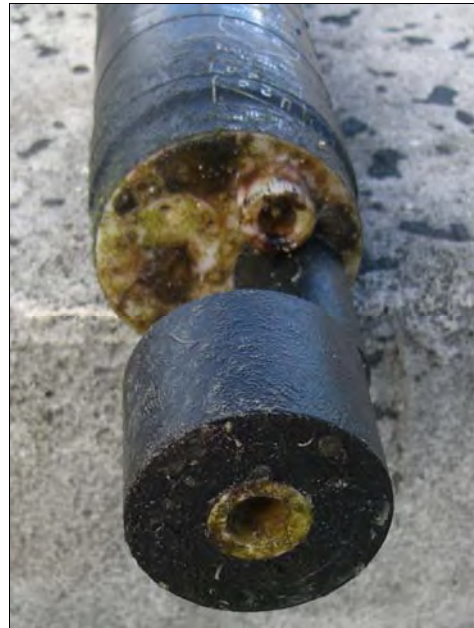
Before and after photos were taken of the instrument to examine the extent and possible impacts of bio-fouling (Fig. 22). The extent of bio-fouling was significantly less at this test site relative to FL or GA despite the longer deployment period and was mostly comprised of plant material and worm cases.

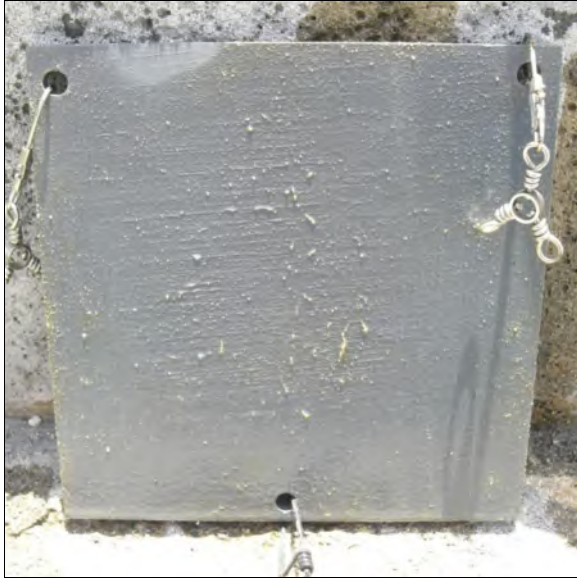
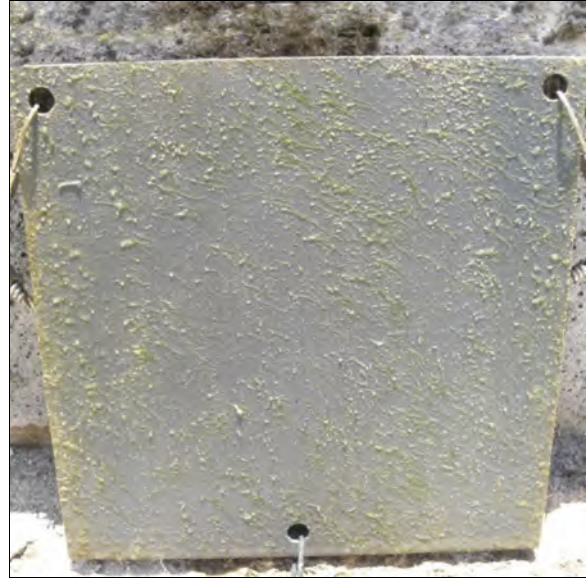
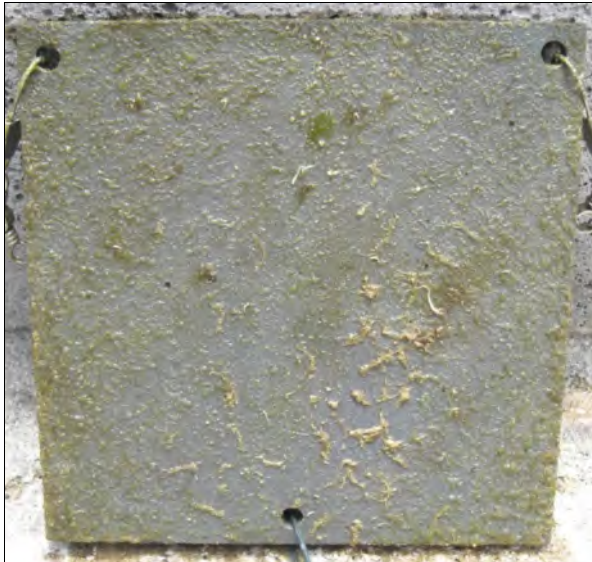
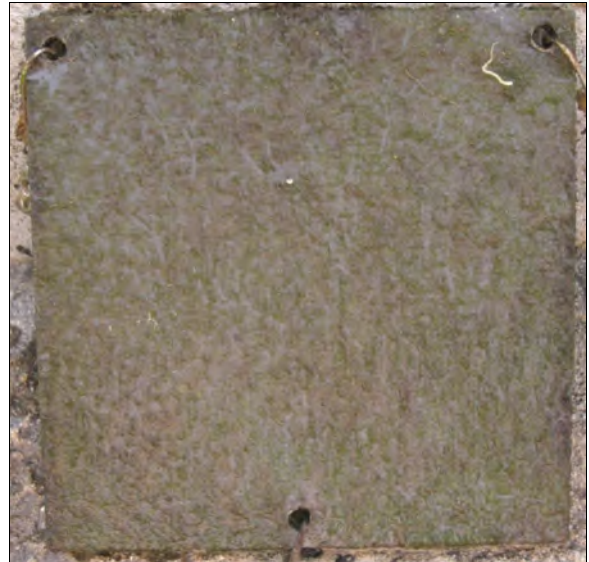
Bio-fouling plates were retrieved and photographed once each week throughout the deployment to help define the rate and extent of biofouling within the test environment. A subset of the plate photographs covering weeks 1, 2, 4, and 8 are shown in Figure 23. The extent of bio-fouling was significantly less at this test site relative to FL or GA despite the longer deployment period and was mostly comprised of plant material and worm cases.

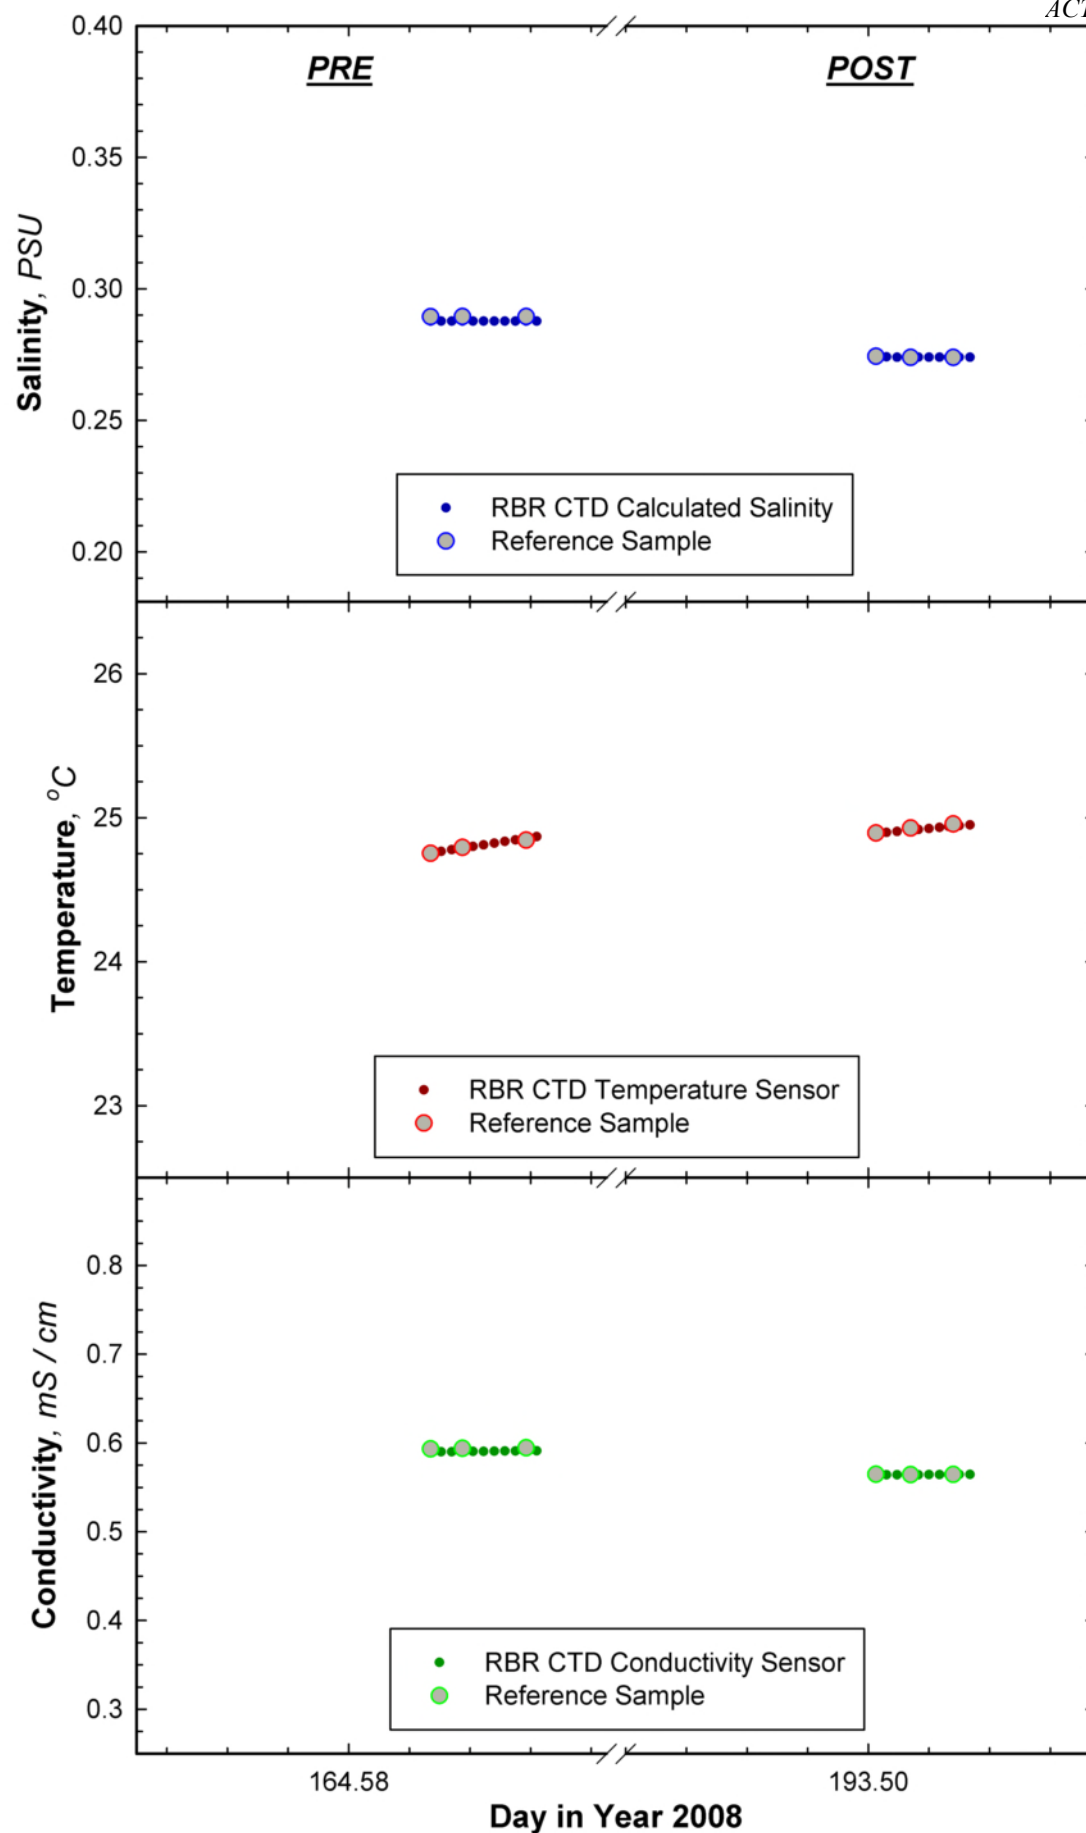
**Figure 27.** Pre- and Post-deployment reference checks in tanks of river water at GL. Post-deployment tests conducted after cleaning instrument of all fouling material according to manufacturer's recommendations.

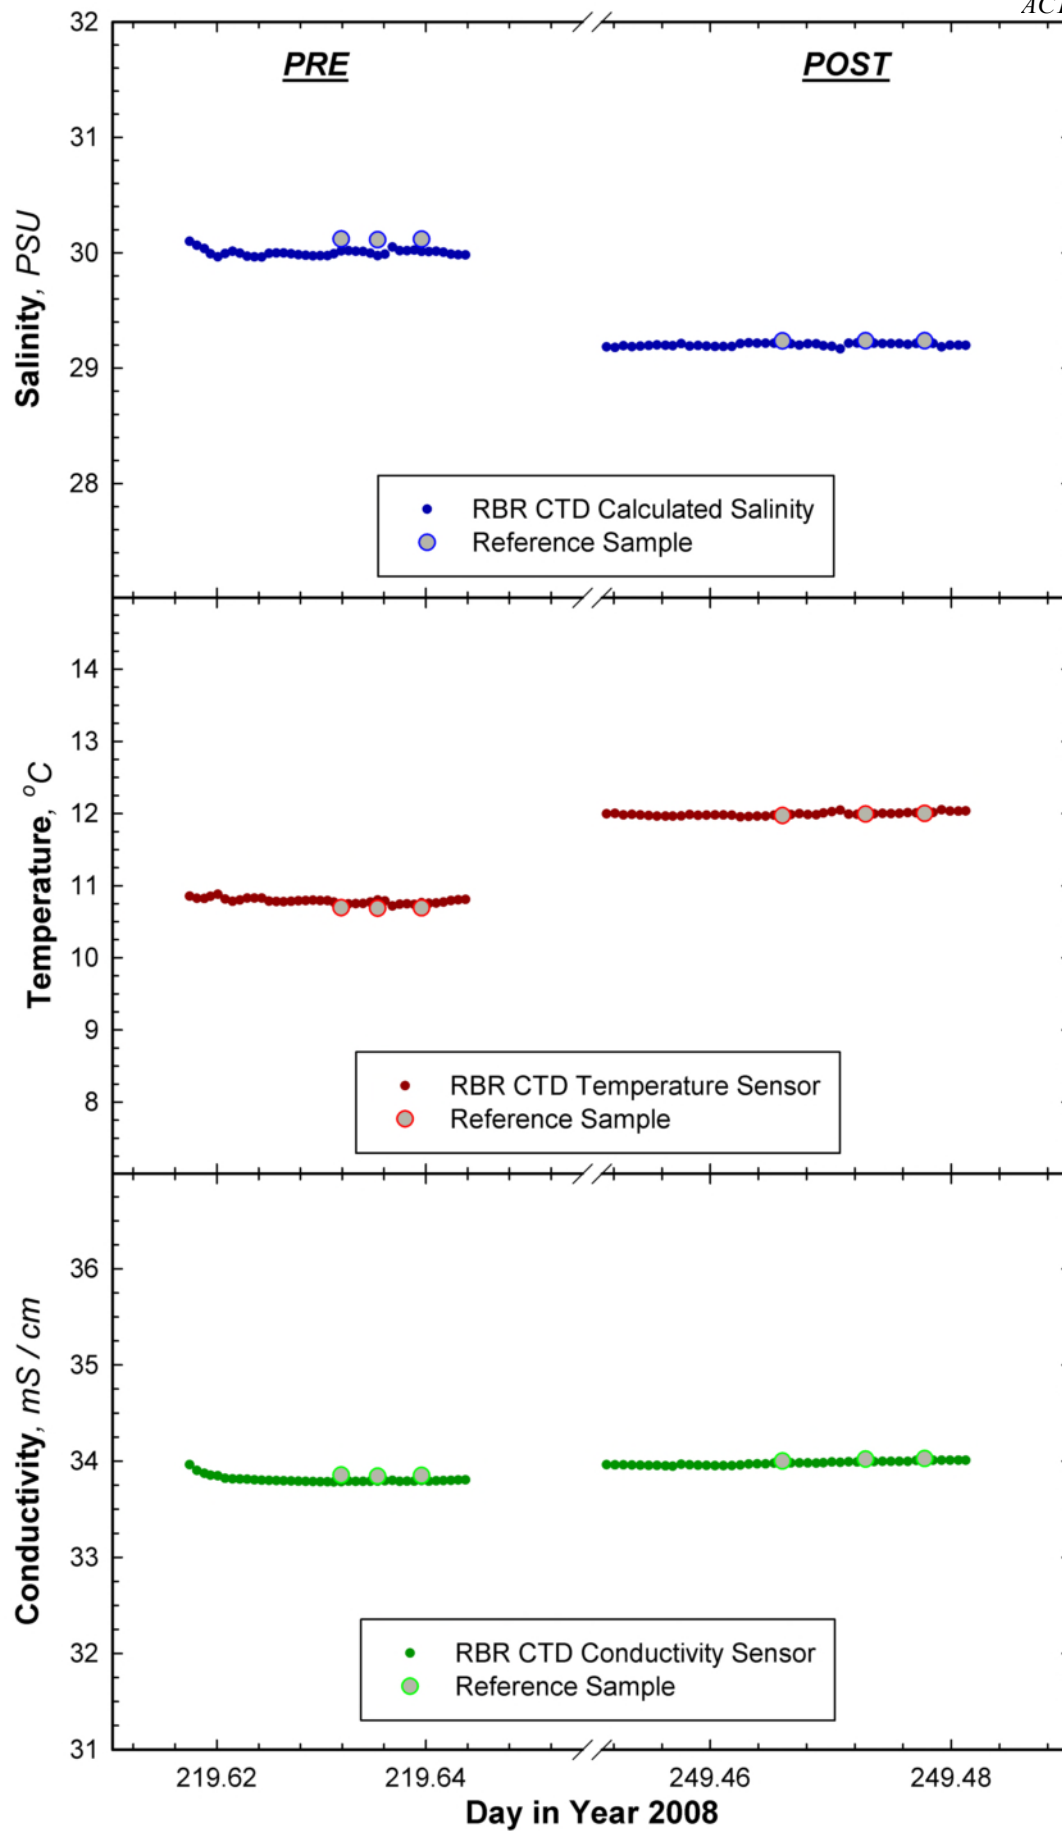
**Figure 33.** Pre- and Post-deployment reference checks in tanks of natural seawater at AK. Post-deployment tests conducted after cleaning instrument of all fouling material according to manufacturer's recommendations.

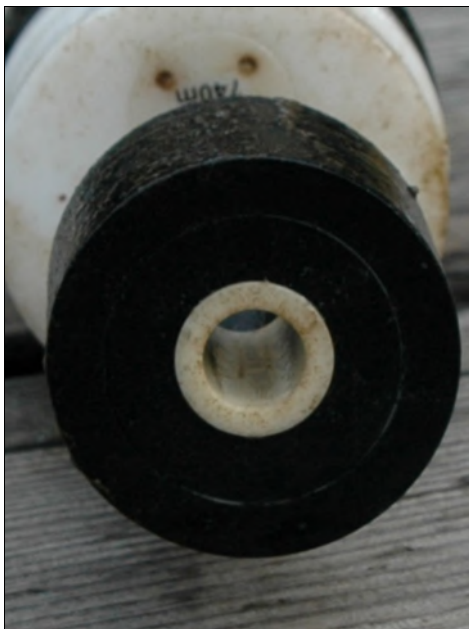
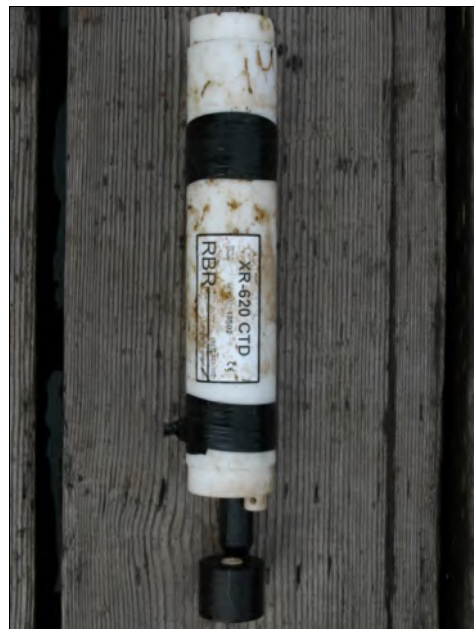
Before and after photos were taken of the instrument to examine the extent and possible impacts of bio-fouling (Fig. 34). The extent of bio-fouling at the AK test site was very small and the lowest of any of the five test sites. No hard fouling was observed.
